A THESIS ON

**EVALUATION OF DAMAGE CAUSED TO ROAD STRUCTURAL
PAVEMENTS BY UTILITY SERVICE PROVIDERS**

A CASE STUDY OF KIGALI CITY

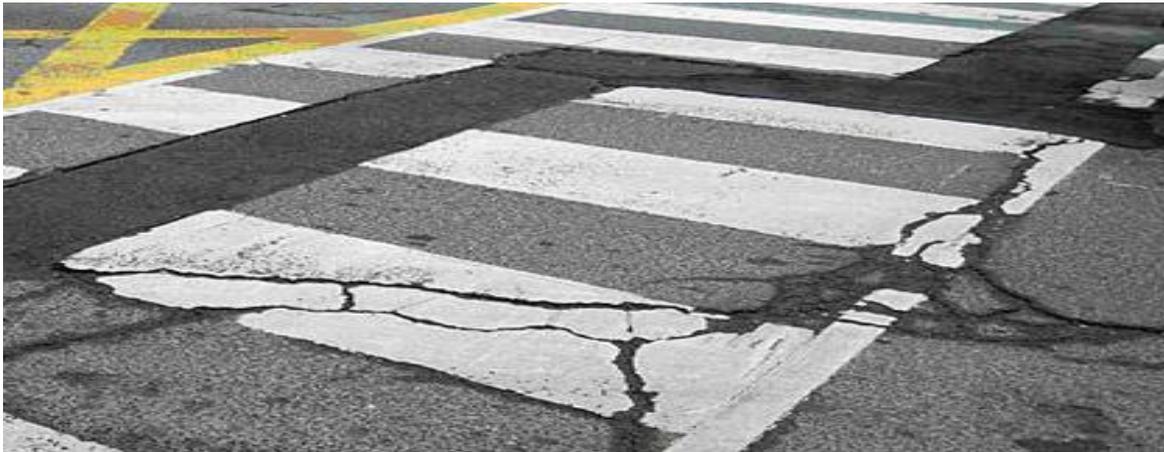
Photo 2: Multiples of repaired utility cuts for different companies bearing pothole, cracks and depressions

The potholes and cracks resulting from activities of utility service providers as shown in above picture are readily visible on road structural pavements in Rwanda, many of which are varying in measurement overtime, but this is not ascertained.

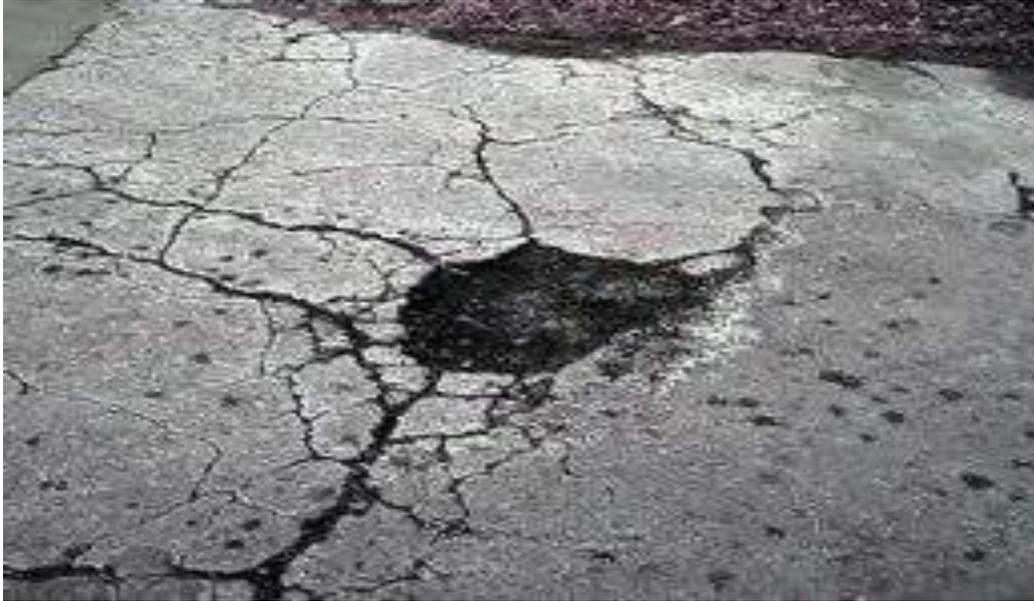
Photo 3: Utility cut, not repaired, with depression

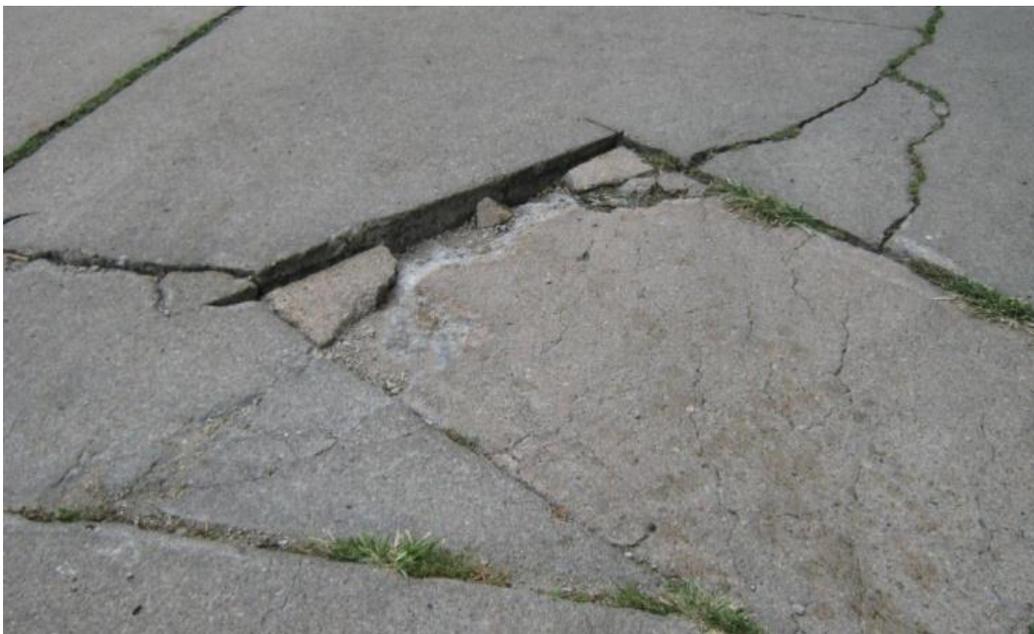
Photo 4: Utility cuts, repaired but not well compacted

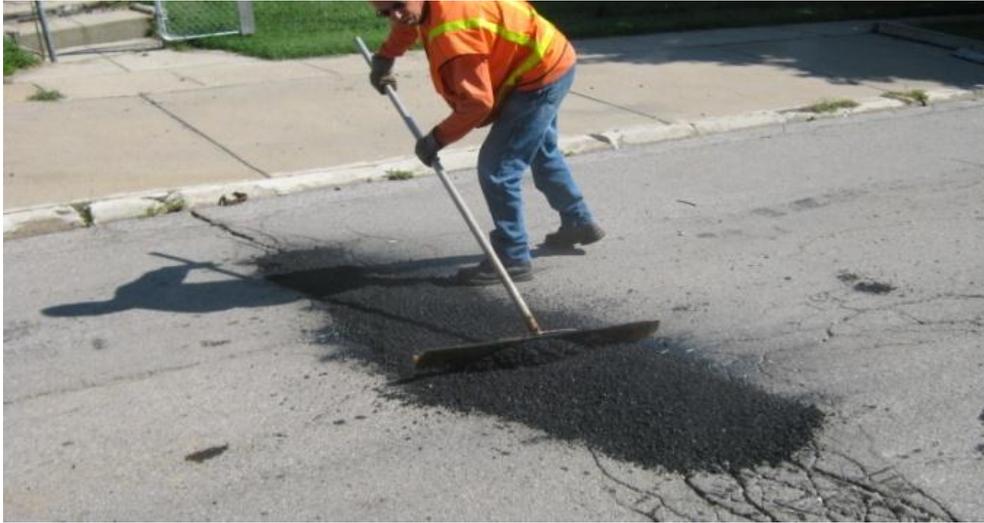
Photo 5: Repairing the utility cuts

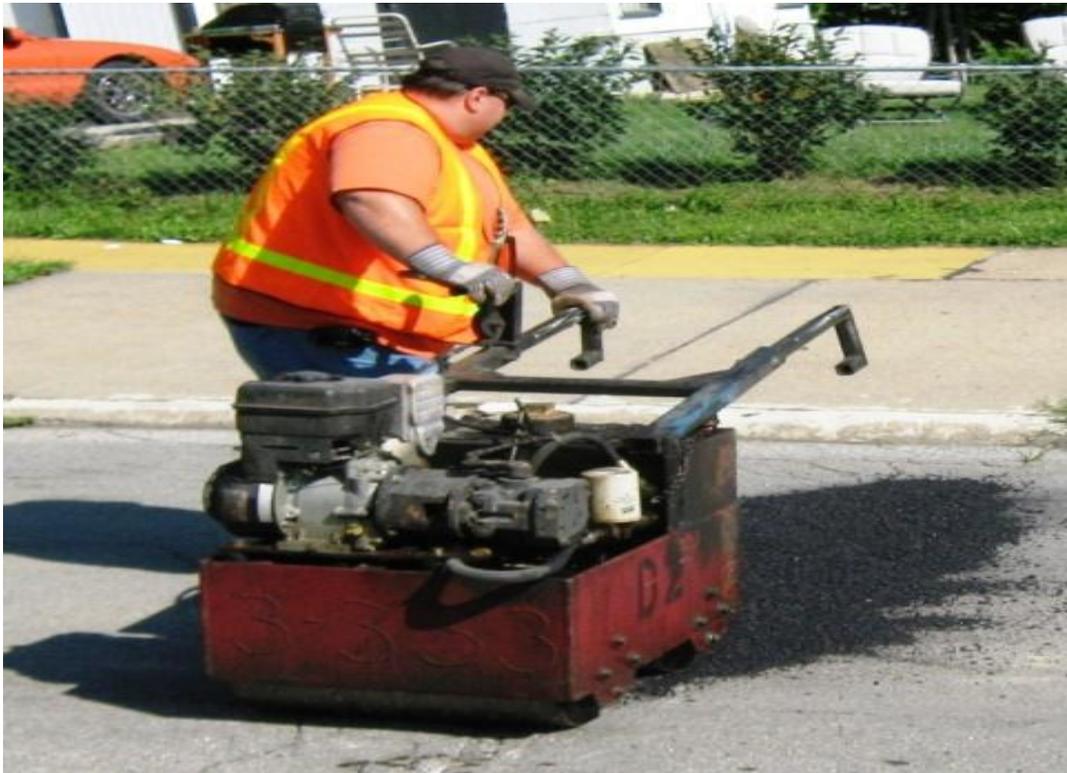
Photo 6: Compaction of asphalt on the utility cuts

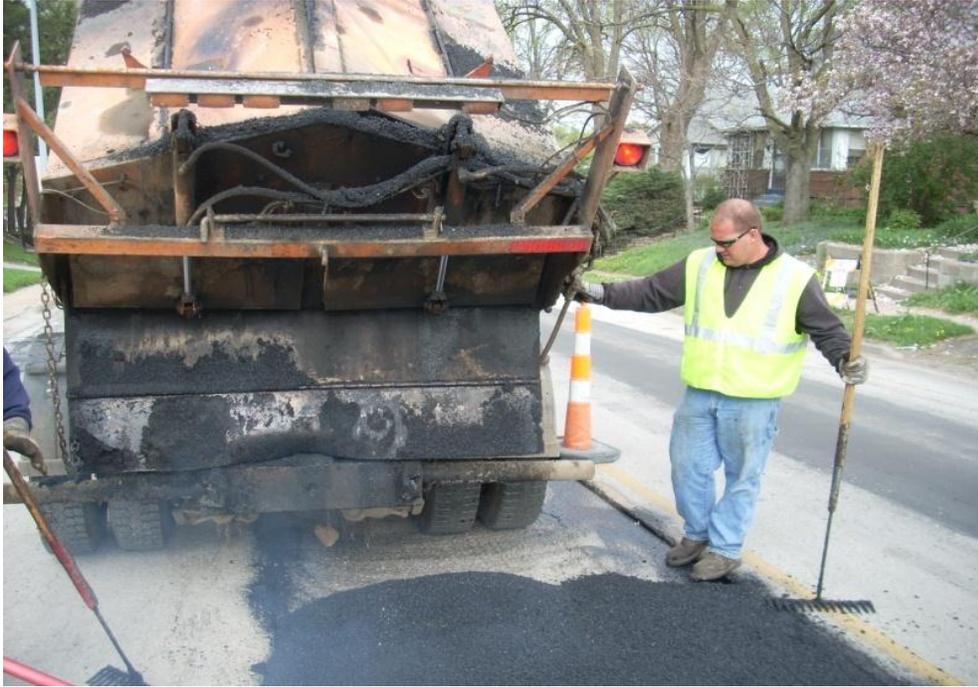
Photo 7: Repair of utility cuts

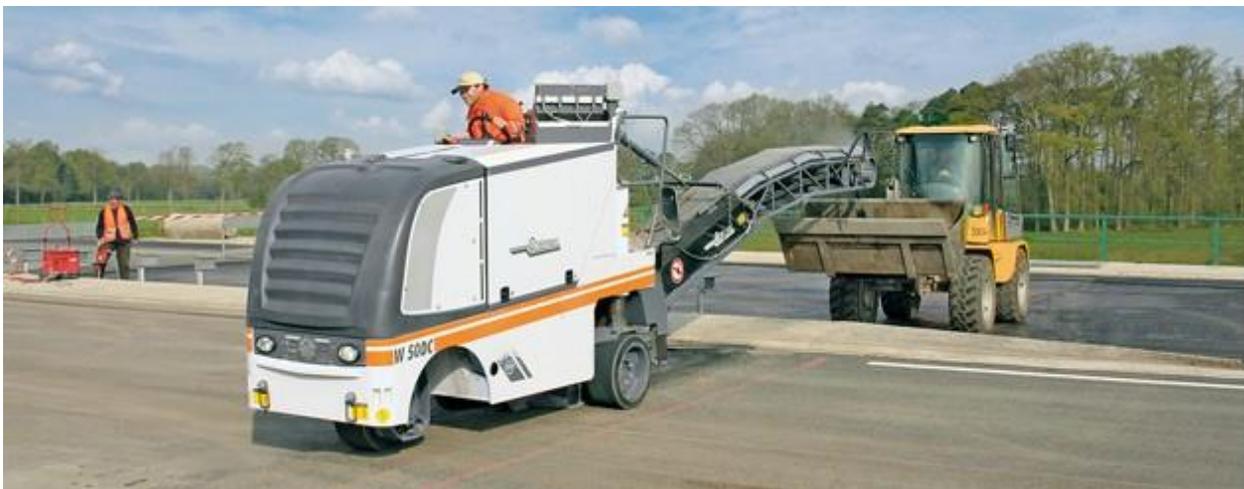
Photo 8: Utility cut

The view above not based on an evaluation of selection of materials and compaction of wearing course.

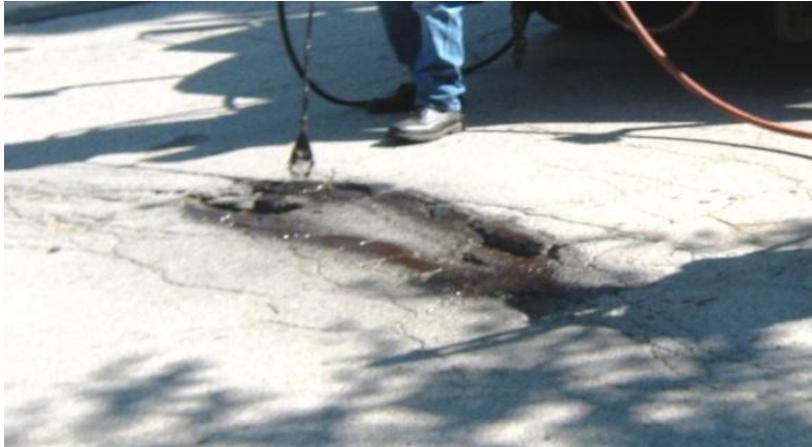
Photo 9: Repaired utility cut with extended pothole and cracks that affect road life and serviceability

Alick (2002) cited in the New Zealand utilities Advisory Group (2003) reported that, over 1000 trenches in Wellington were not reinstated properly. Alick, further observed that, it is estimated that digging up a road even once reduces life of the pavement by 30%. This is also supported by Bodocsi (1995) where it is pointed out that a new asphalt pavement lasts from 15 to 20 years. Furthermore, Bodocsi (1995, pointed out that once a cut is made, the pavement life is reduced to about 8 years in the area of the patched pavement. Tie water (1997) is also in agreement with Bodocsi (1995) who states that several excavations in pavements by utility companies can reduce road life by 50% as per below picture .

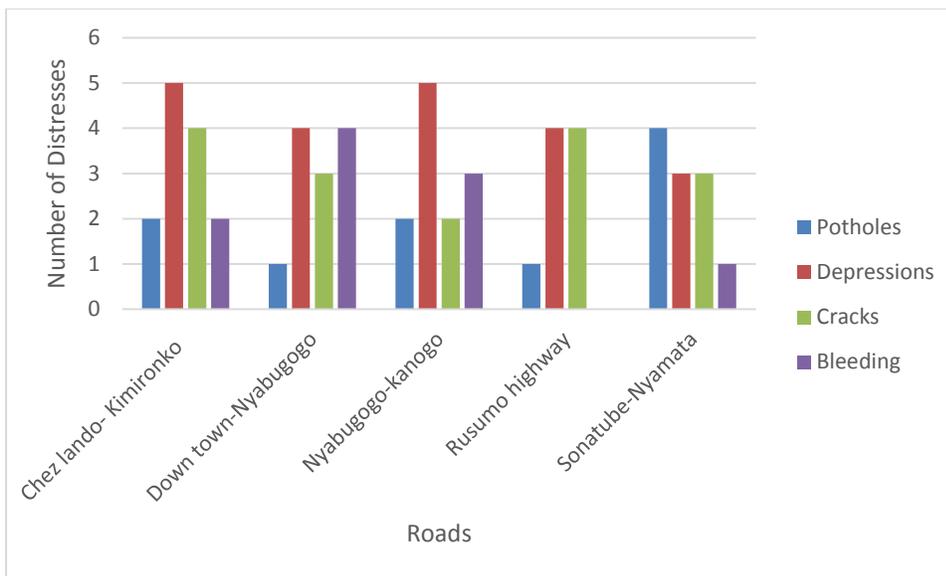
The study revealed potholes, depressions, cracks and bleeding and their frequencies on the five (5) selected roads in Kigali. It was established that three (3) out of the five repaired roads cuts developed all the four forms of distresses. The general overview established that depressions ranked highest, followed by cracks, bleeding and potholes respectively.

Figure 5: Types of distresses observed on roads in Kigali

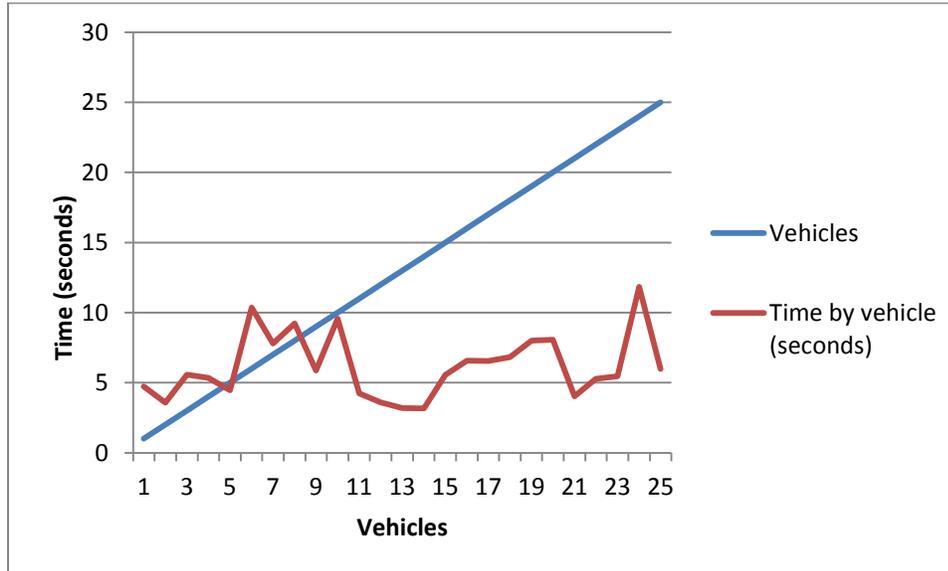
The study investigated the effects of distresses with the view to establish whether they cause unnecessary traffic jam to road users. A pothole was identified purposively at a repaired utility cut. A sample of twenty five (25) vehicles irrespective of their length, sizes or axle load were tested considering the time wasted at pothole. Time taken by each vehicle was recorded using a stop clock and an average of 154.81 seconds (2.58 minutes) was taken by vehicles at this pothole as seen in Figure 7.

Figure 7: Variations in time taken by vehicles at a pothole

The findings reveal variation in time taken by vehicles to overcome either potholes or depressions as demonstrated by the delay and reduction in travel speed and time. This consequently led into queues of vehicles at the spot causing unnecessary traffic jams to road users. In 2013 between August to November, at SonatubeRwandex road where there is utility cuts lasted for about three months without being repaired properly caused unnecessary traffic jam. In summary, it was asserted that utility cut distresses lead to increase costs of maintenance to the road authority, reduction in roadway service lives and unnecessary traffic jam to road users.
