**Environmental Compliance in Rwanda:  
“A Case of Cassiterite-Coltan Exploitation in  
Karengwe Sector”**

**Master’s of Science in Geo-Information for Environmental and Sustainable  
Development**

June 2017

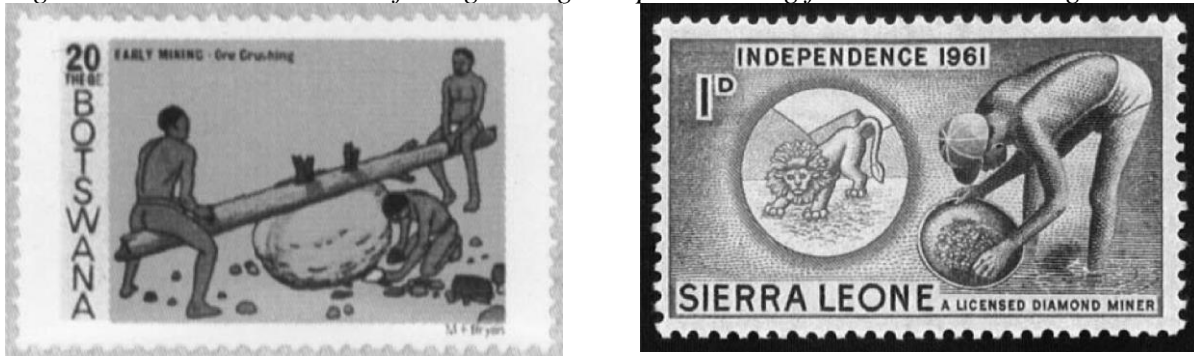
smelting. According to the same author, ore grinding is a technology commonly used by many Africans before the introduction of machines. A large granite boulder was tilted back and forth by two men sitting on a wooden beam fixed on top of the boulder (see figure 1-1).

*Figure 1-1: Ancient method of ore grinding and pan washing for mineral including diamonds*

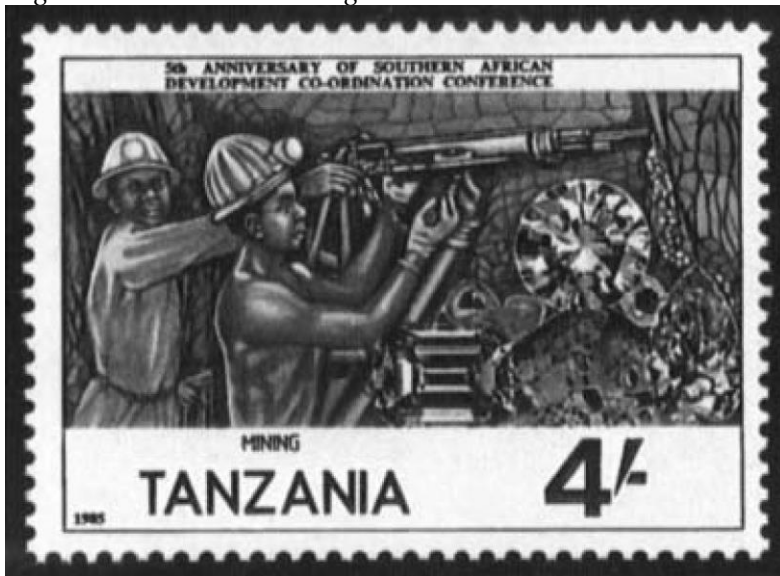
Modern mining methods were later introduced by Europeans in 19<sup>th</sup> century. The figure (see figure 1-2) below illustrates miners in Tanzania using drilling machine and wearing protective equipment in mining.

*Figure 1-2: Modern mining*

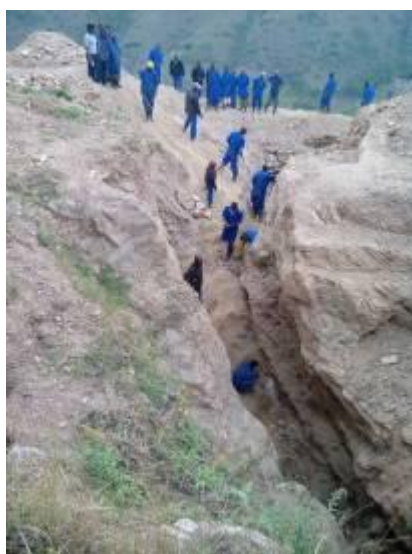
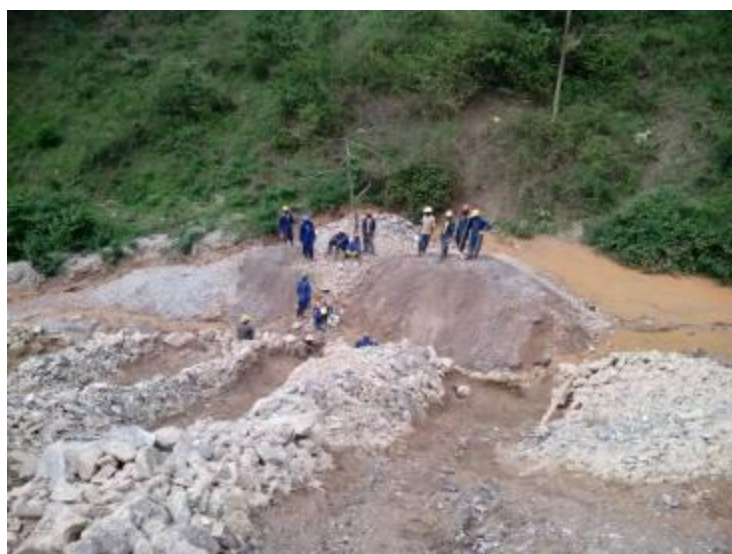
*Photo 1-1: Artisanal mining sites in Rwanda*

An artisanal mine site in Murundi and Rukara sectors, of Kayonza District in Murundi and Rwimishinya cells.

An artisanal ore washing at Rutongo Mines in Rulindo District, Northern Province of Rwanda

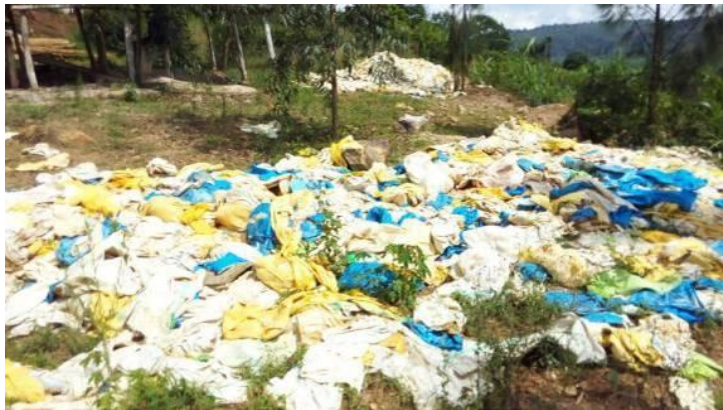
Erosion is also crucial on this site. However, the 2013 approved EMP/EIA of HABATU Mining Ltd recommends that non-hazardous wastes be collected and disposed at an approved sanitary landfill and soil erosion must be reduced (HABATU, 2013).

*Photo 1-2: Inappropriate disposal of used plastic bags at HABATU Mining sites*

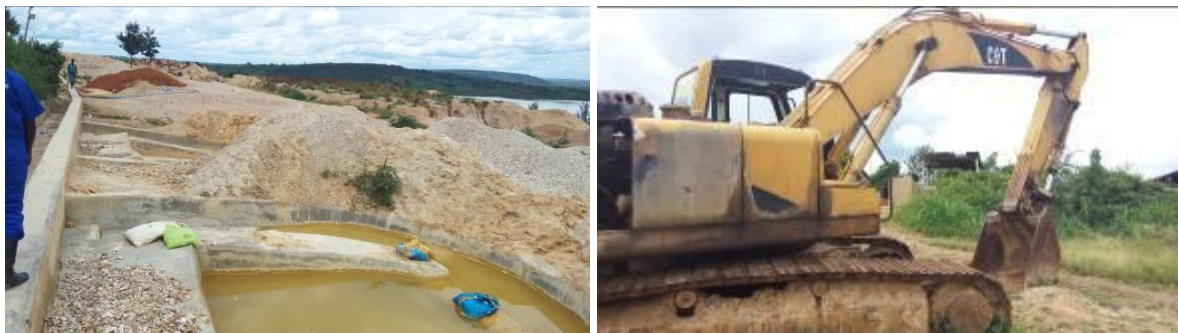
In general, the mine has basic infrastructures including offices, stores, bathrooms, toilets to serve miners and employees working in offices and in different corners of the concession. Many of their tunnels are electrified; they have a well organized and improved mineral washing system which minimizes the use of water and a bulldozer machine to clear when the site is burdened by waste soil, rocks and mineral tailings, especially to prevent waste water to contaminate the nearby Mugesera Lake and its wetland. This relatively high investment reflects the potential and richness of the mineral reserve at that mine.

*Photo 4-3 Mineral washing facility and an excavator used for various sites clearing activities*

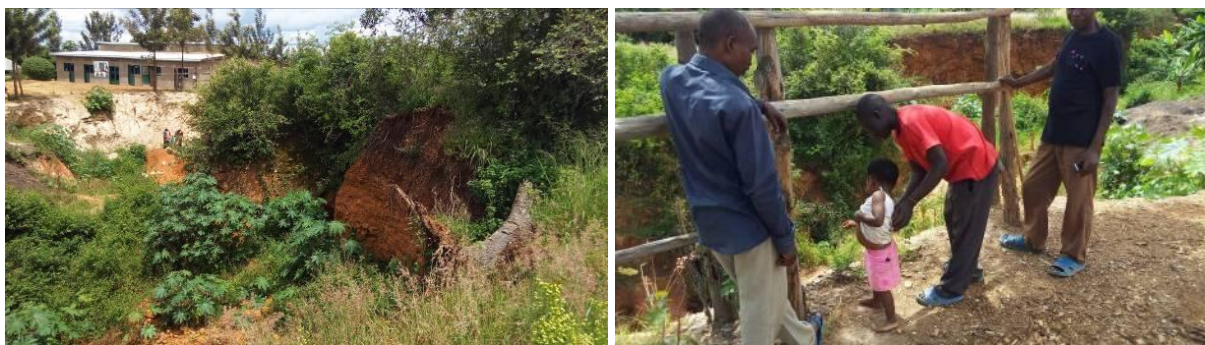
Failure to comply with REMA and RDB requirements which are advising a systematic rehabilitation of the exploited sites in a such way that the new site opening goes systematically with full restoration of the previous ones RDB (2013), made the mine have abandoned/old pits sites which are unfilled/non-restored with soil and vegetation. That unfilled site presents a huge accident risk to mine workers, nearby residents (even babies who can sometimes move within the active sites with adults) and domestic animals (see photo 4-2), as the site was extracted in an opencast, pits and tunnel systems, and is around 15 meters deep with a diameter of many dozens of meters. The site findings concur with Kabatesi (2014), who stated that excavated pits are left unfilled.

*Photo 4-4: Non-fenced, unfilled and abandoned site at H&B*

Among the observed environmental problems include the risk of accidents on employees due to a 15 meters deep abandoned site with a diameter of many dozens of meters which is not filled and vegetated. This is in contradiction with this mine EIA/EMP approved by RDB in 2013. The latter advises a systematic rehabilitation of the exploited sites in a such way that the new site opening goes systematically with full restoration of the previous ones.

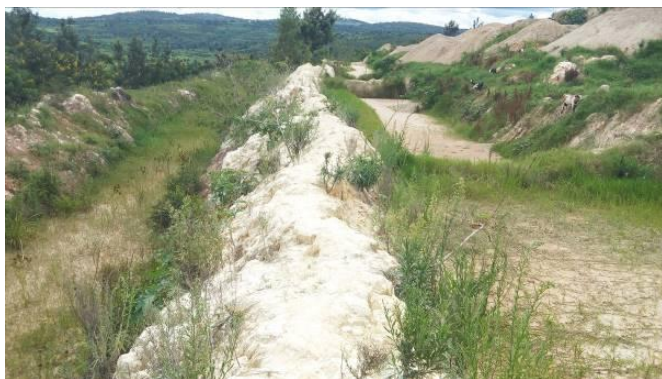
during the site visits. As results, soil erosion on those massive mineral wastes is very serious to the level that if nothing is done, the nearby Mugesera Lake wetland will be polluted and silted as well. Then push further the reasoning on the possible consequence of the pollution and silting on water resources, water treatment because the water of the lake is treated and distributed to the population in the area and Kigali. Another risk of drying up of the lake because silting exposes more surface area, this increases the evapotranspiration.

*Photo 4-5: Insufficient protecting vegetation on abandoned waste soil*

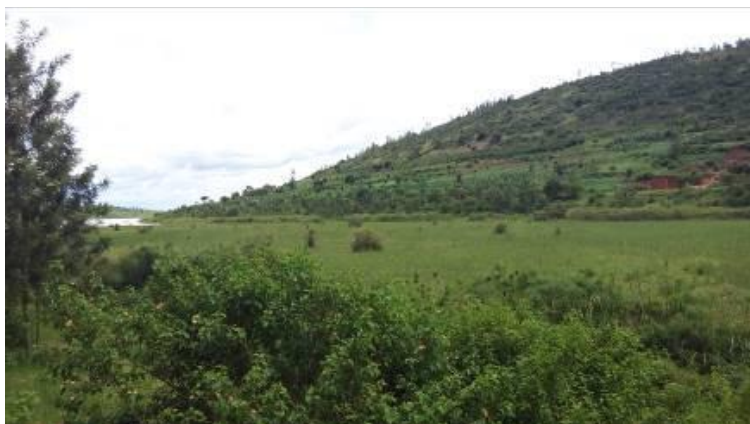
One of the critical environmental component that is not followed up, and yet it appears among the mine EIA requirements, whereby the monitoring of water levels (by the mine company) in adjacent land to tailings ponds should be conducted RDB (2013). The field evaluation revealed that, there is no measurement or monitoring data available nor conducted on water levels especially that the mine operates a few hundred meters away from Mugesera Lake wetland (see picture 4-6). This is a fragile ecosystem that needs frequent mentoring to check the toxic chemical elements that might have infiltrated the wetland through water runoff and erosion.

REMA (2015) confirms that the mining and/or processing activities at all of the studied mines release waste into rivers, onto adjacent agricultural lands and close to settlements. It also recognizes that the main threats are from dumps of mine tailings and waste released from processing plants.

*Photo 4-6: Mugesera Lake wetland separates two hills where H&B mines.*

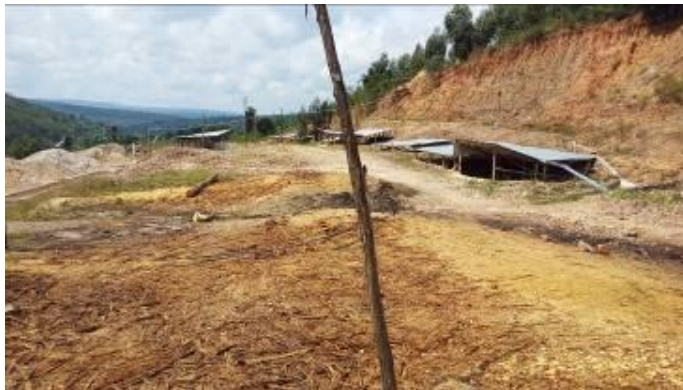
At this mine, the main mining operations take place in Nyamatete and Bicaca cells of Karenge Sector. Minerals are mined in deep underground electrified tunnels even though the EIA does not clarify whether mining operations should be underground or open cast (source). Operators choose themselves the mining methods depending on the geology and mineralized veins and costs involved. The electricity is generated by power generator machines and mining activities are taking place on the land acquired by the company after compensating the previous tenants.

*Photo 4-7: General view of one of HABATU active sites*

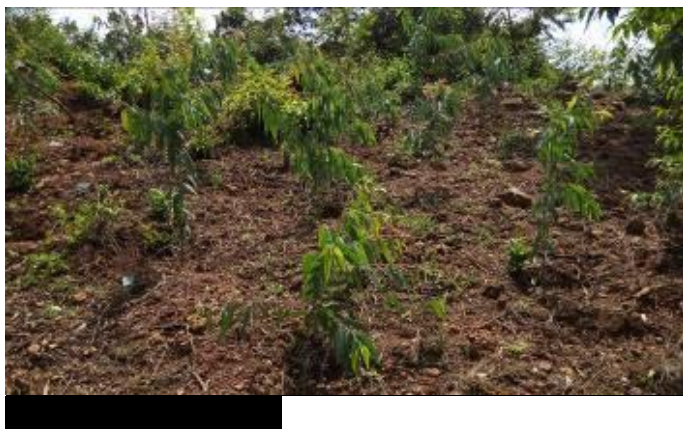
*Photo: 4-8: Old mine site being vegetated at HABATU mine*

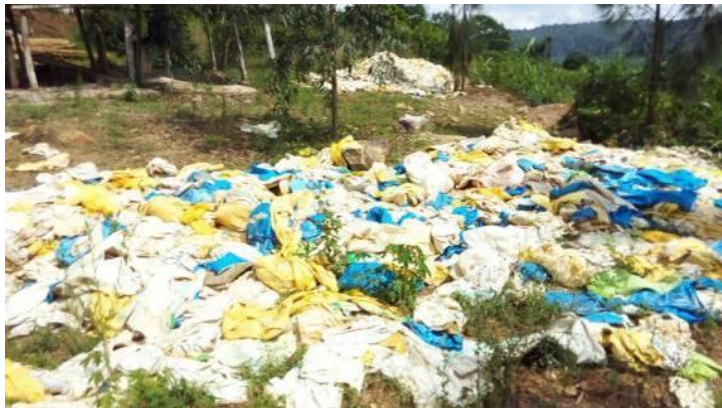
The field observation revealed the presence of scattered utilized plastic bags near the tunnel entrance and mineral washing place. These are bags used by miners to transport minerals sand from inside the tunnel to the washing place. Their presence is in contradiction to the mine’s EMP advising to dispose nonhazardous wastes to approved dumping site, HABATU (2013). It is important to recall the REMA, 2006 use of plastic ban on Rwanda Territory. Some of the most common consequences of scattered plastic bags are that they prevent water infiltration and some of them may contaminate the soil with chemicals (polythene) they are made of.

*Photo 4-9: Inappropriate disposal of used plastic bags*

Also, the presence of scattered used plastics bags on the active were also detected. It is contraction with the mine obligation to properly dispose non-hazardous waste. Another serious

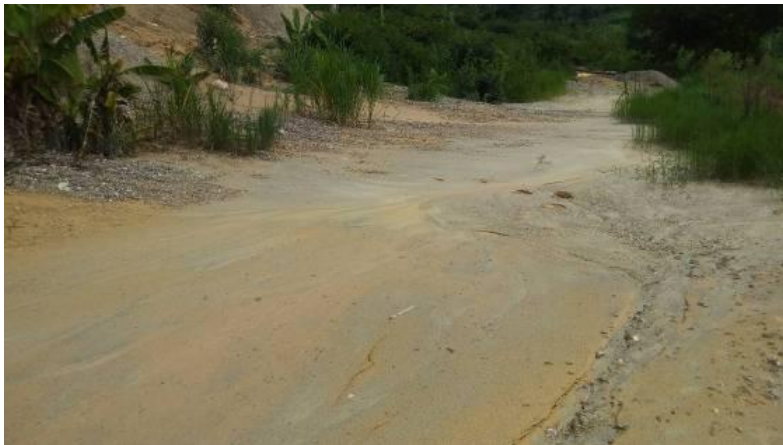
It is also in the views of REMA (2015) that mining has local impacts on water quality with the potential for heavy metals (lead, cadmium, zinc, copper) to accumulate in soils and enter the food chain, especially in floodplains used for agriculture and irrigation.

*Photo 4-10: Erosion of waste soil at HABATU mine*

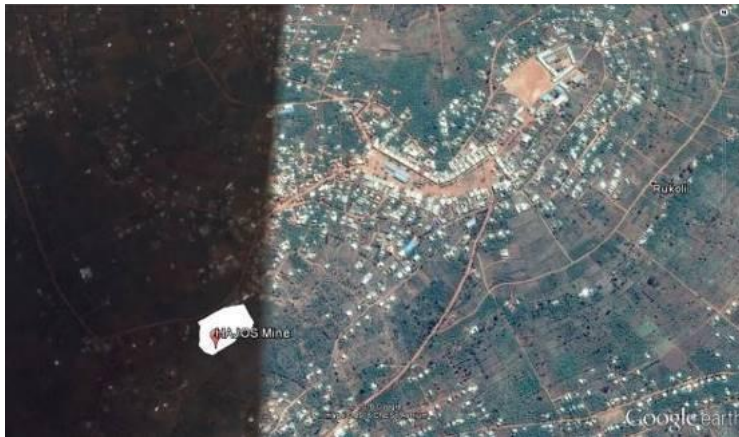
The active tunnels being located at less than 100 meters before Karengé trading center on right on the main, in Karengé Cell, this mine is not doing much to put into actions its EMP. As general direct and foreseen environmental issues, are those of residents leaving in less than 50 meters from the tunnels and pits, in some parts, the mine is not well fenced to avoid mine accidents that may happen especially due to unfilled and abandoned sites and degradation of farmland around due to soil overburden. Lucky enough, the mine is free of severe erosion due to the relatively flat terrain where mining operations active in addition to the mine underground operations.

*Photo 4-11: HAJOS Mines within Karengé trading center*

The white stain on this google image shows the location of HAJOS which is very close to the Karengé trading center and within residential houses.
