A THESIS REPORTON

**“IMPROVEMENT OF COBBLESTONE ROAD CONDITIONS VERSUS RIDING
QUALITY IN THE CITY OF KIGALI”**

**MASTERS OF SCIENCE DEGREE IN
HIGHWAY ENGINEERING AND MANAGEMENT**

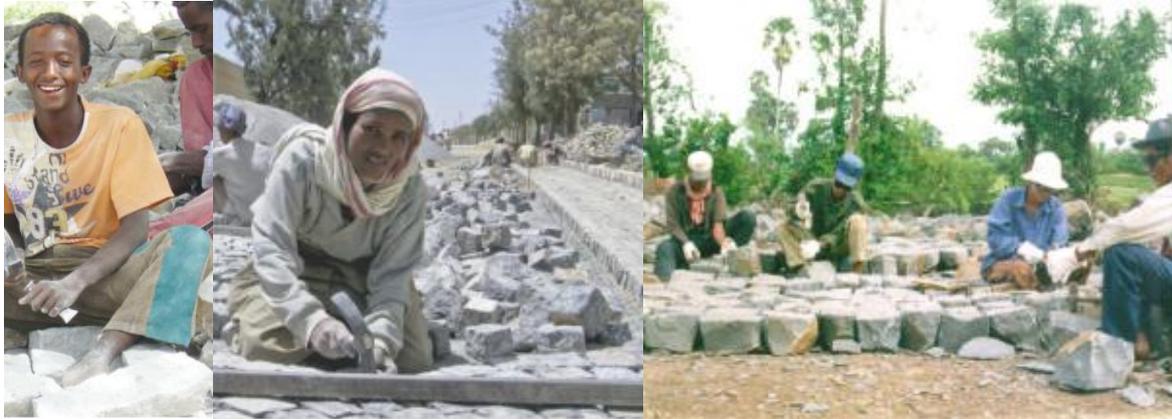
dimensions), to the technique of laying cobbles (joints, laying style) and to the degradation of the pavement (Areaurbanisme, 2011). Cobblestones present bumpy surface finishing because they are traditionally manually made, which makes them uncomfortable for driving as shown in Figure 2.4.

Figure 2-4: Human production of cobblestones in Ethiopia (Giz/Ethiopia, 2008)

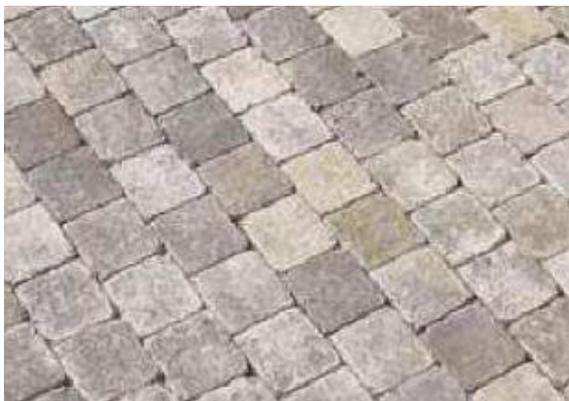
Some styles of laying cobblestones proposed by ILO (1992) such as mosaic and arch layout styles contributed only to the stability and aesthetic of cobblestone roads but not to its comfort.

Figure 2-5 : Mosaic layout (ILO, 1992)

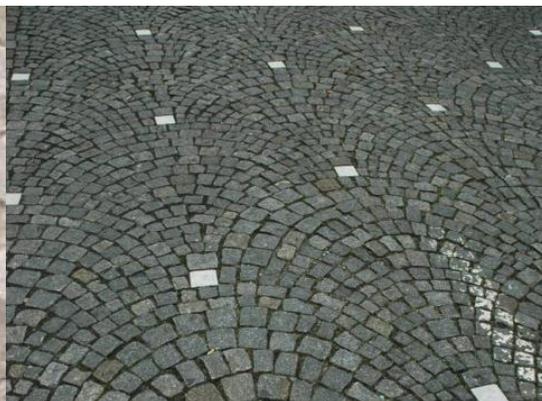
Figure 2-6: Arch layout (ILO, 1992)

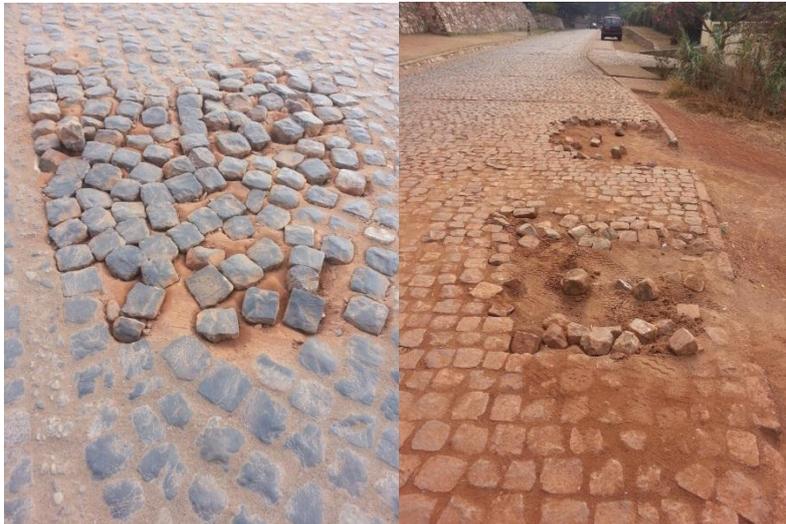
In Rwanda the unevenness of cobblestones is not the only source of uncomfortable riding. One of the causes of poor riding quality is the early degradation of the surfacing materials characterised by the displacement of cobblestones as shown in Figure 2.5 below.

Figure 2-7: Degradation at Gisimenti & Kacyiru roads

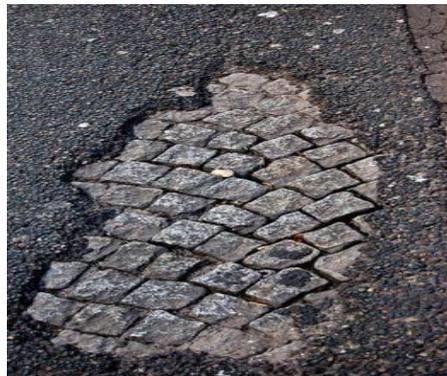
By the time of issuing the patent to Guidet's pavement, the riding quality was not an issue since the pavement was fitting the draught animal. However, after the arrival of cars in replacement of draught animals, pavements in ancient cobblestones were rejected and some of them were covered by bituminous pavement materials because they were uncomfortable for vehicles and cyclists (Areaurbanisme, 2011).

Figure 2-8: Covering ancient cobblestone road with bituminous materials (Areaurbanisme, 2011)

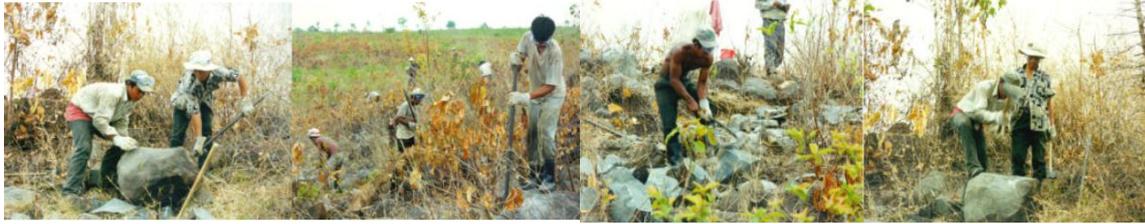
Quarrying, channelling and cutting are the steps needed to prepare the blocks (Samer, 2001). Ordinarily hand tools used for quarrying; breaking and shaping are sledgehammers, club hammers, crowbars and chisels are used by labourer. For larger stones, wedge holes are prepared along the channelled line at intervals of 150-200mm. A club hammer and grooving chisel are used to make wedge holes, 70mm long and 40mm wide. Once this is completed, the worker can crack and break the boulder with a sledgehammer along the channelled line.

Figure 2-14: Labour based quarrying using crowbars Figure 2-15: Breaking the stones with a sledgehammer (Samer, 2001)

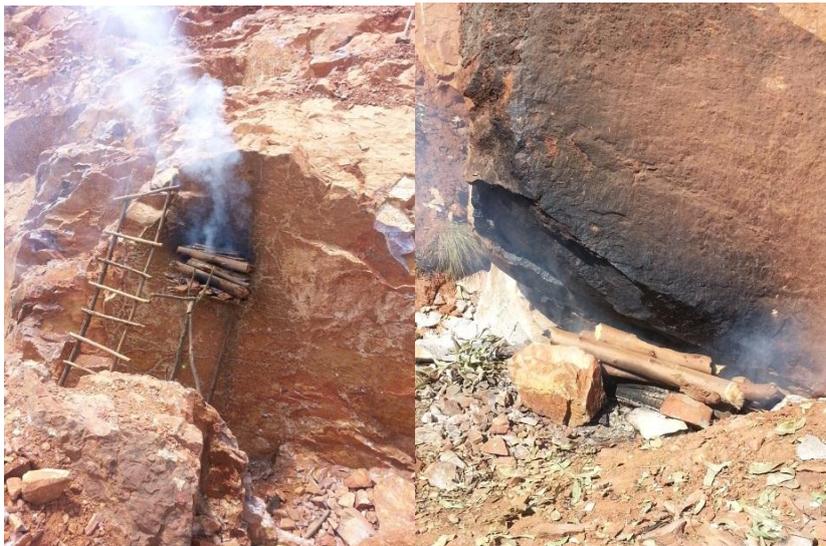
Locally, continuous big rocks are intensively heated by using firewood before breaking them into smaller blocks with a sledgehammer. The heat applied to the rock surface reduces the cohesion of rocks particles which facilitate the rock workers to break it with minimum efforts.

Figure 2-16: Heating the rock with firewood at Mont Kigali quarry

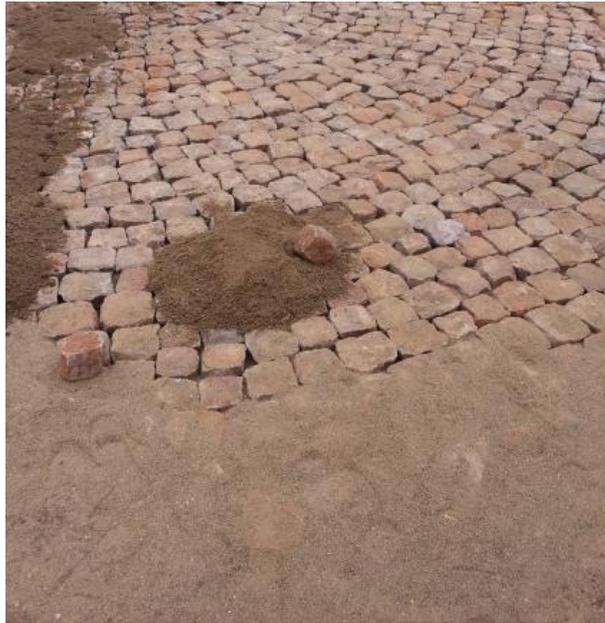
Once the stone blocks are laid, dry fine graded sand is swept over the paved area ensuring that all joints are full (Boral, 2007). Areaurbanisme (2011) recommend a joint of dimension less or equal to 2cm between stone blocks.

Figure 2-19: Filling the joints during the construction of Gitega road

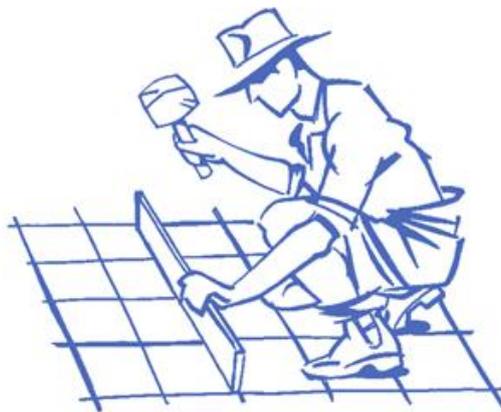
Boral (2007) recommends to compact paved stones by using a mechanical plate compactor with a piece of carpet or rubber mat under the compactor to prevent the cobblestones from being scratched or damaged. For small areas, the compaction may be done by using a hammer and a hardwood plank as shown in Figure 2.19.

Figure 2-20: Compaction of paved stones (Boral, 2007)

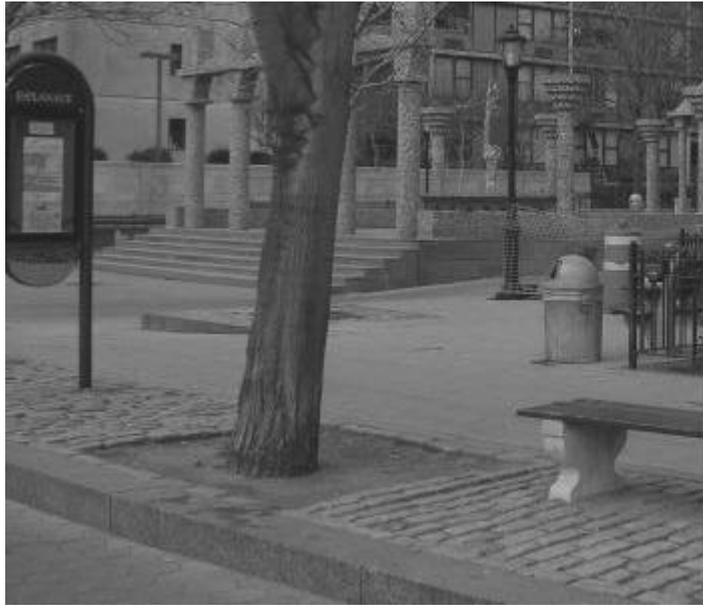
There is also a trend of extending the aesthetic reinterpretation of cobblestones outside of historic neighborhoods. In New York, numerous sidewalk and park paving projects have used these stone blocks as landscaping features. As shown in Figure 2.21, it can be seen that cobblestone are not used as actual paths but as edging. People go on the stone surface to sit down and to stop moving, not to get somewhere else (Treskon, 2006).

Figure 2-22: Stone Paving in Battery Park City, Manhattan (Treskon, 2006)

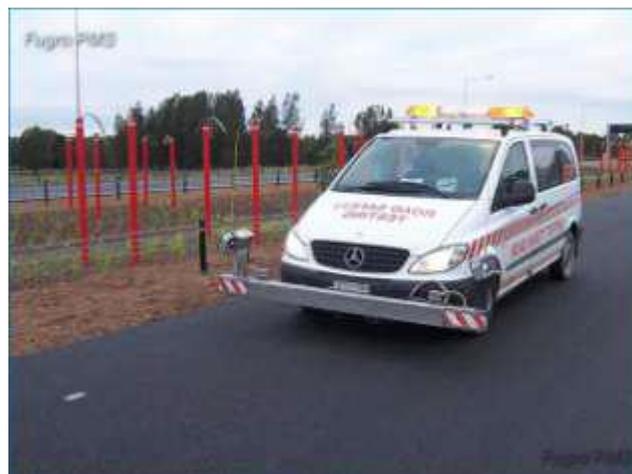
The principal components of a *high-speed profiler* are laser-based height sensors, accelerometers and an accurate distance measuring system (Brown *et al.*, 2010). The height sensors record the distance to the pavement surface from the vehicle. The accelerometers, located on top of the height sensors, record the vertical acceleration of the sensor. Double integration of the vertical acceleration gives the vertical displacement of the vehicle. The longitudinal profile is then derived from these two height measurements. The distance measuring system ties the measurements to a reference starting point. The non-contact height sensors currently used in profilers are either laser or ultrasonic waves. Figure 2.23 shows a typical high-speed profiler with 13 laser sensors.

Figure 2-24 : Laser profiler (Brown, 2010)

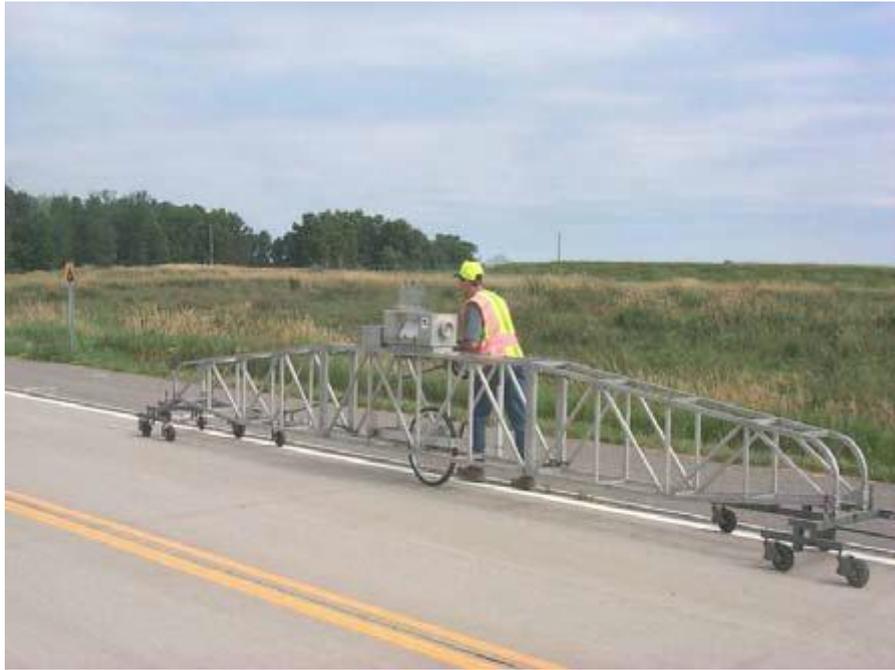
In contrast with the high-speed laser profiler, a *profilograph* consists of a rigid beam or frame with a system of support wheels at either end and a central wheel. This wheel is linked to a strip chart recorder or a computer that records the movement of the wheel from the established datum of the support wheels. The major difference between the high-speed profiler and the profilograph is that they use different reference planes and different filtering to record the surface profile. The profiler is a network survey device while the profilographs are widely used to evaluate the as-constructed smoothness of new pavements and overlays (Brown *et al.*, 2010). Figure 2.24 shows the California profilograph.

Figure 2-25 Truss-type California profilograph (Brown, 2010)

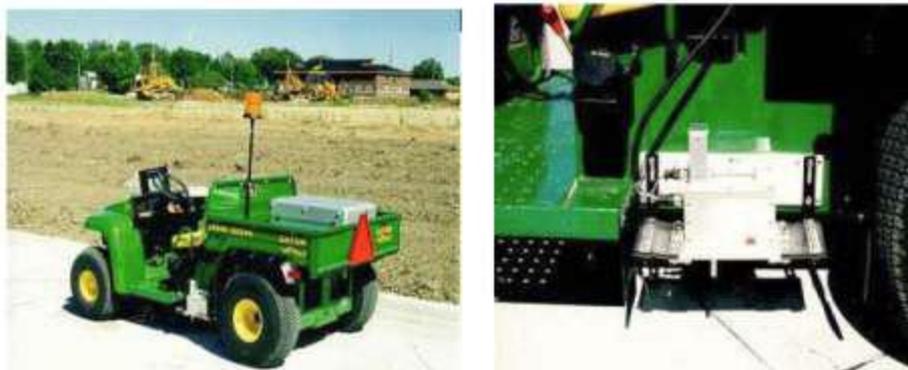
Light-weight profilers (Figure 2.26) are increasingly used to evaluate new construction. The term lightweight profiler refers to devices in which a profiling system has been installed on a light vehicle, such as a golf cart or an all-terrain vehicle. The profiling system in the light-weight profilers is similar to ones used in high-speed profilers. The profile data is commonly used to simulate a profilograph over the pavement section, generate a profile index (PI) and identify bump locations. The profile data can also be used to compute other roughness indices, such as the IRI or ride number (RN).

Figure 2-26 Lightweight profiler and non-contact sensor (Brown, 2010)

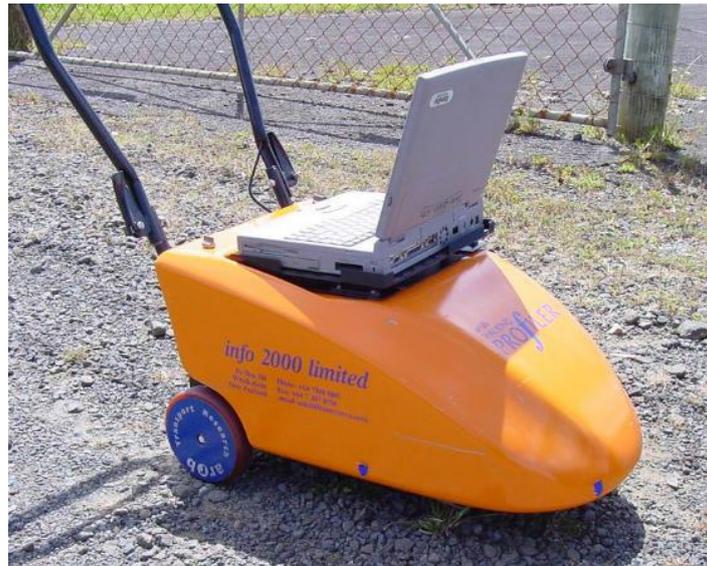
obtaining the true elevations along a pavement surface and its standard reference procedure is described in the ASTM E-1364. The dipstick and walking profilers usually use an inclinometer between two support feet or multiple wheels to compute the surface profile. The general procedure to verify the output from road profilers is to collect profile data at test sections using a manual reference device, then compute a roughness index such as the IRI from that data and compare the result with the output from the road profiler.

Figure 2-27: Walking profiler with cowl on and Laptop Mounted (Gregory, 2006)

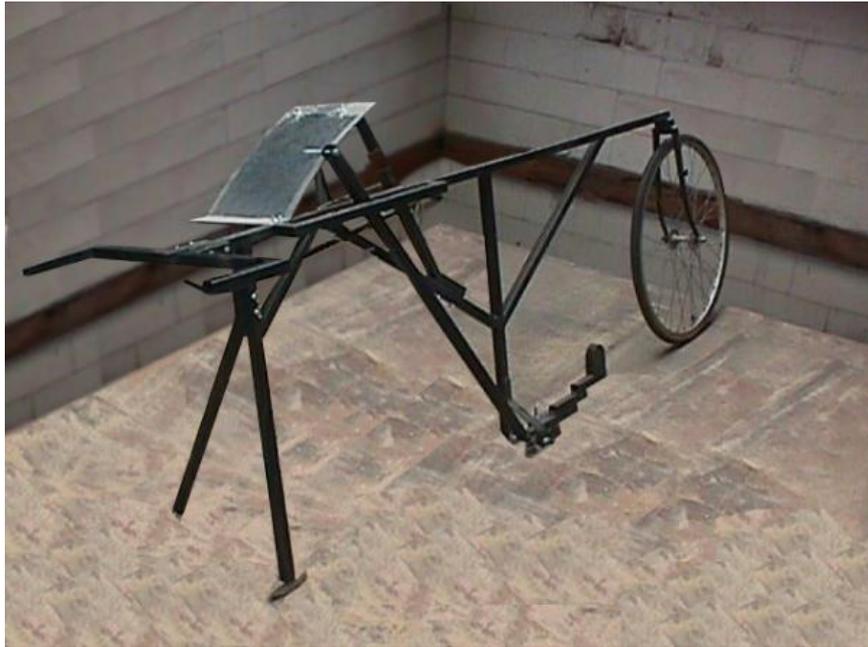
In this category of manual devices, a MARLIN shown on Figure 2.27 is widely used as a simple roughness measuring machine that has been designed for use in developing countries. *Merlin* stands for a Machine for evaluating roughness using Low-cost Instrumentation (Cundill, 1999). It can be used to calculate roughness directly, or for calibrating other more automated roughness collection devices, such as vehicle mounted response meters. The device consists of a metal frame 1.8m in length, a bicycle tyre at the front, a foot at the rear, and a moving foot mid-way to record the mid-chord deflection (Gregory, 2006).

Figure 2-28 Merlin machine for evaluating roughness (Greggory, 2006)

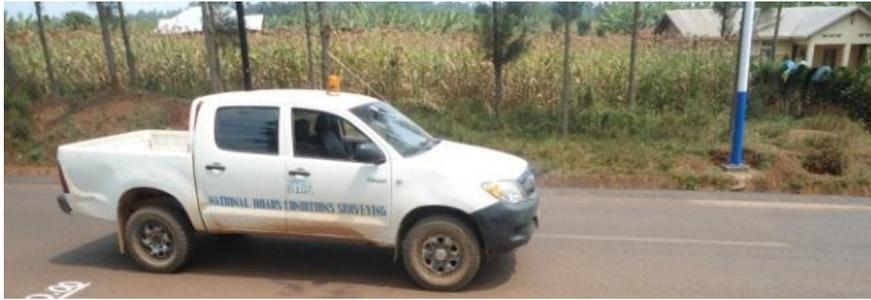
The BI was mounted inside the deck of the survey vehicle of type pick up, into both the centreline of the vehicle and the axle. Figure 3.1 shows the survey vehicle used during the study and Figure 3.2 shows the bump integrator used during the surveys.

Figure 3-1 Vehicle mounted Bump Integrator belong to RTDA

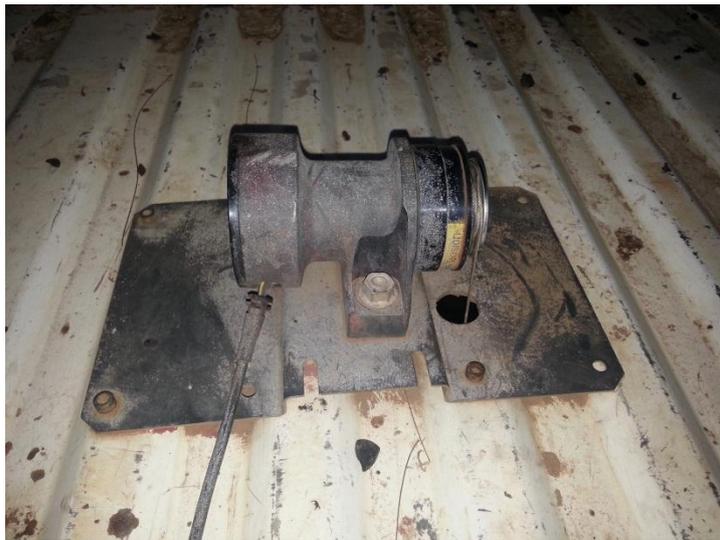
Figure 3-2: Bump Integrator fixed at the vehicle

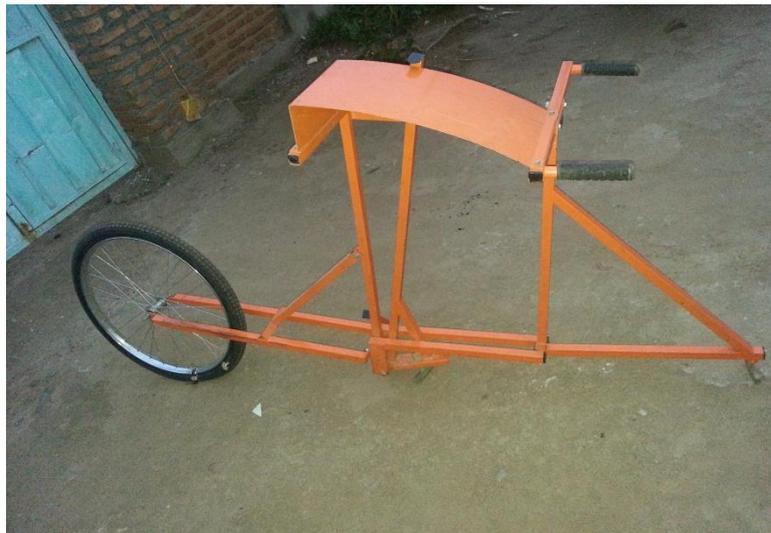
For ease of operation, a wheel is used as the front leg, while the rear leg is a rigid metal rod as shown in Figure 3.5 and schematically presented in Figure 3.6. On one side of the rear leg is a shorter stabilising leg which prevents the device from falling over when taking a reading. Projecting behind the main rear leg are two handles, so that the device looks in some ways like a very long and slender wheelbarrow.

Figure 3-5 The Merlin

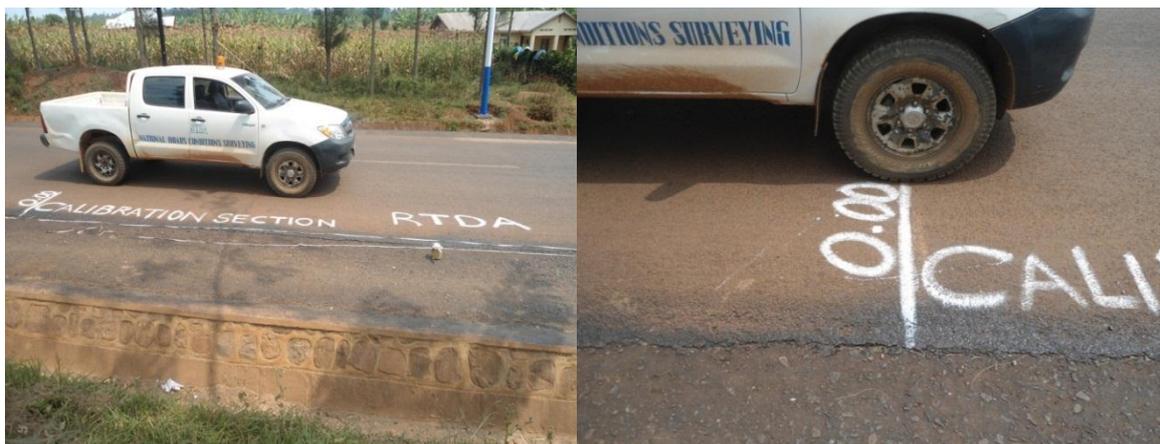
After the identification of calibration sections, the usual traces of vehicle wheels on test sections are materialized by painting them from start to end as shown on Figure 3.8. The traces for the two wheels must be marked out. The start, the end and sub-section of the calibration section must bear the cumulative distances measured from the starting point.

Figure 3-8 : Materialization of calibration sections (RTDA, 2013)

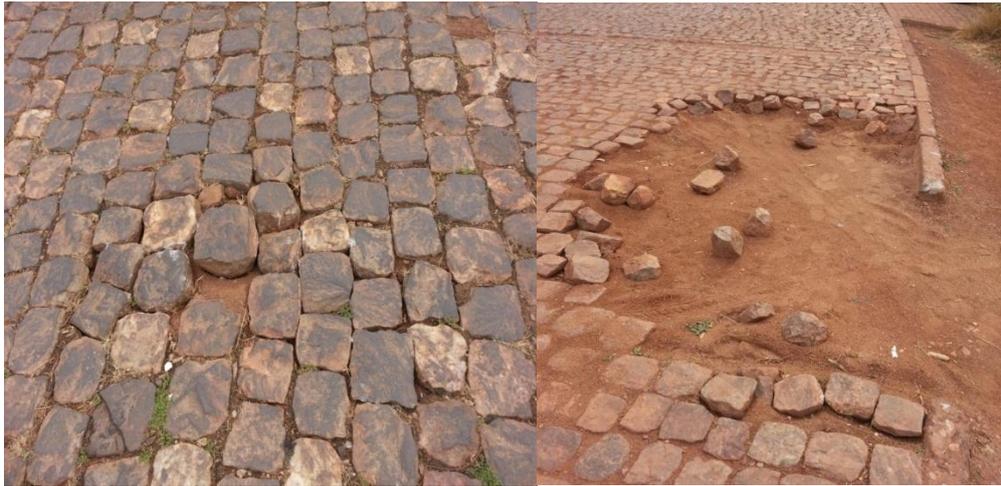
After the displacement of the first stone, other stones follow in the direction imposed by the slope of the road as shown on Figure 4.1. The displacement is significantly influenced by an increase in slope of the road.

Figure 4-1 Start of rock displacement MINAGRI-KACYIRU road

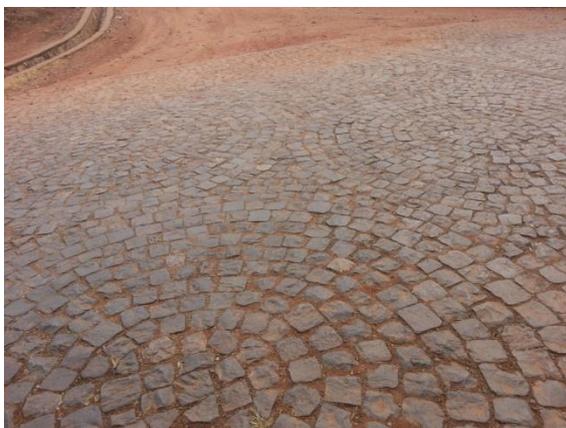
Two laying patterns of cobblestones have been identified on existing cobblestone roads; longitudinal and arch patterns. The visual inspection has shown that the arch laying pattern of cobblestones is more stable against the displacement of cobblestones. Existing cobblestone roads in arch layout have less displacement of cobblestones as indicated in Figure 4-2 and Figure 4-3.

Figure 4-2: Kimihurura road with a stable arch layout

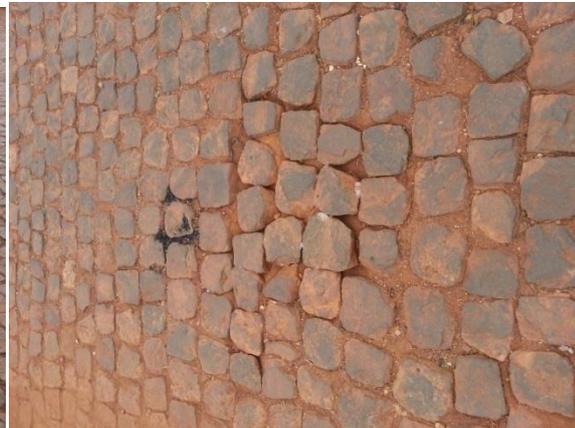
Figure 4-3: Ryanyuma road with a longitudinal laying pattern

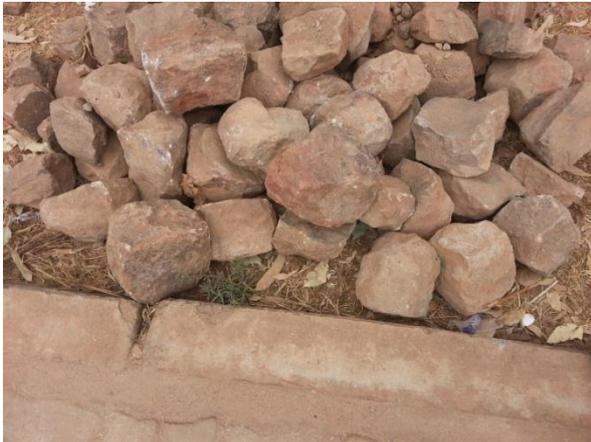
Figure 4-4: Irregularities in shape and dimensions of stones at Mumena road

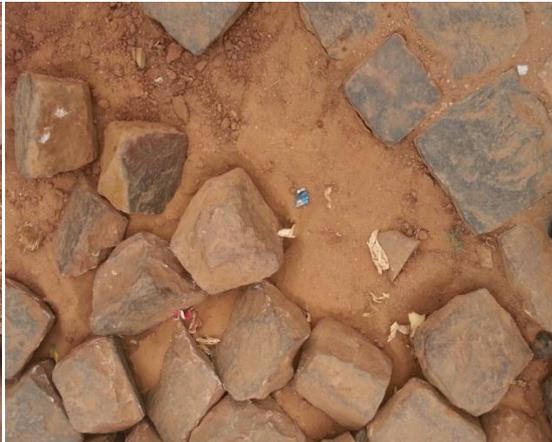
Figure 4-5: Displacement of paved stones at Ntaraga road

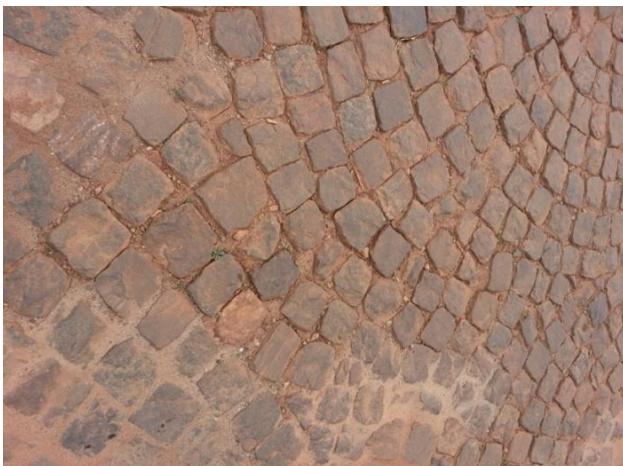
Figure 4-6: Erosion of joints at Mumena road

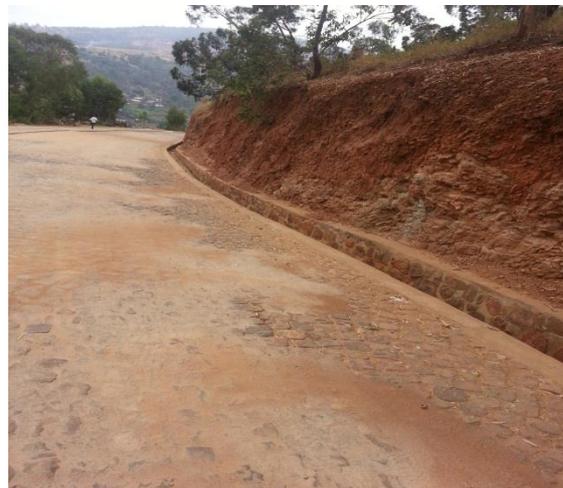
Figure 4-7: Repaired joints at Mumena Road

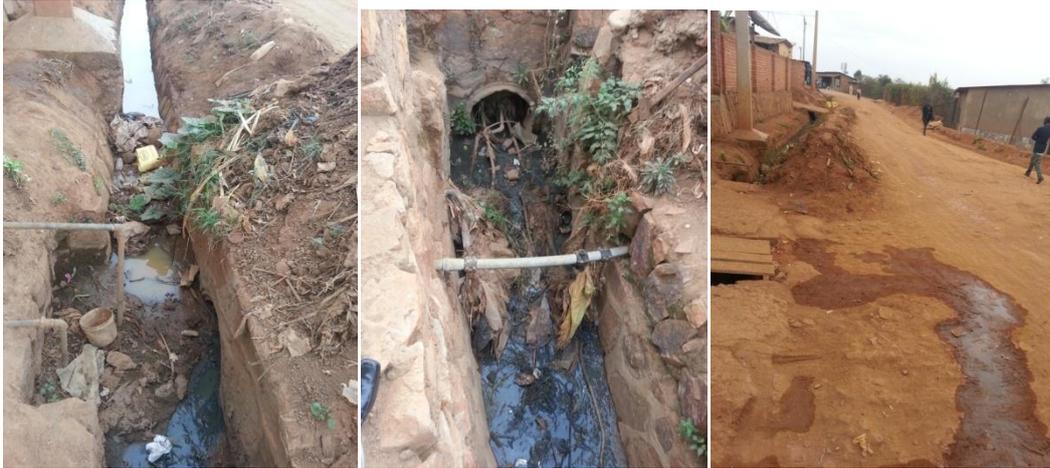
Figure 4-8 Depression at the road surface at Kamuhoza road due to poor maintenance of drainage structures

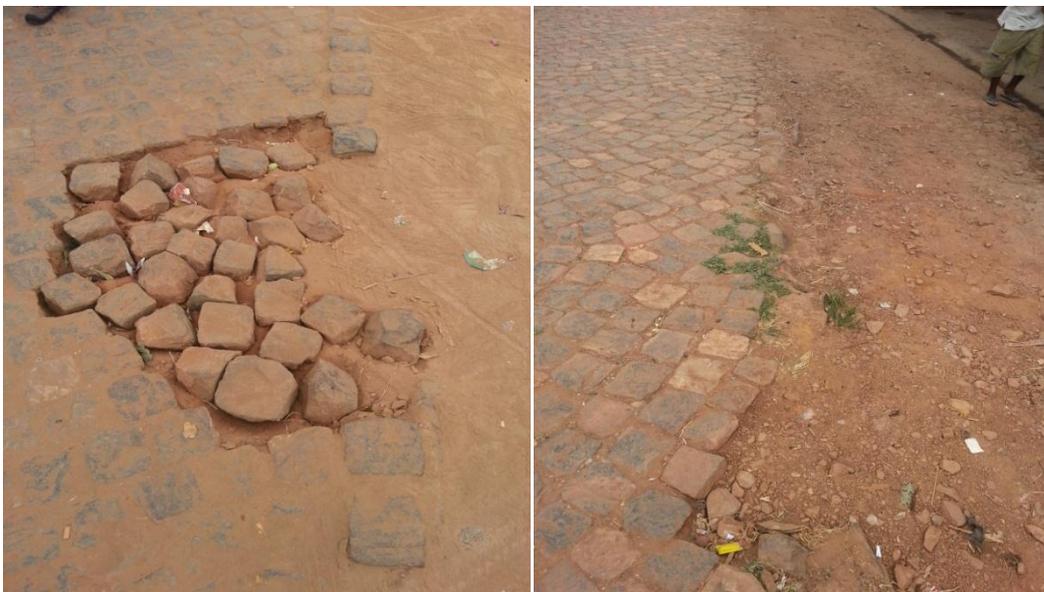
Figure 4-9: Edge break at Kabusunzu road Figure 4-10: Edge break at Kimisagara road

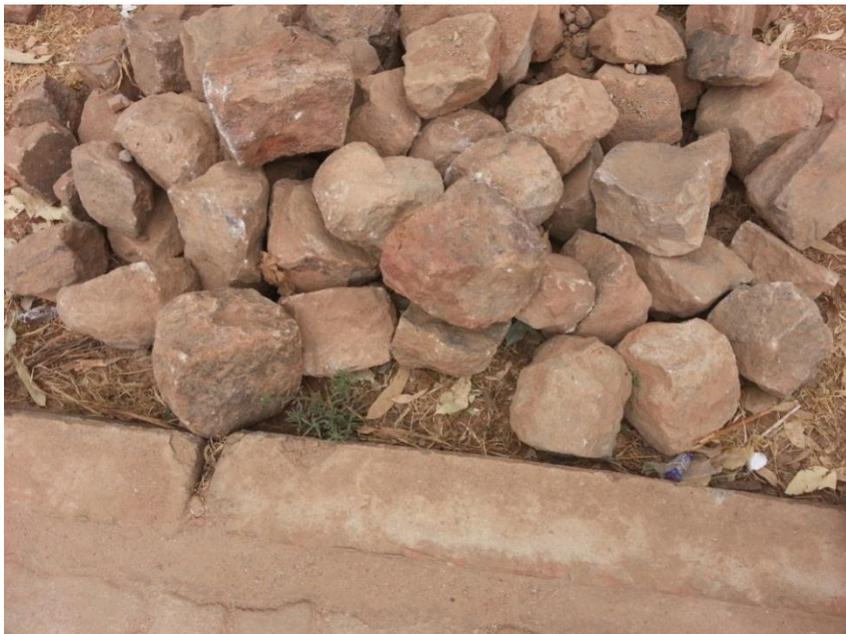
Figure 5-1: Irregularities in shape and dimensions of cobblestone used at Mumena road, Kigali

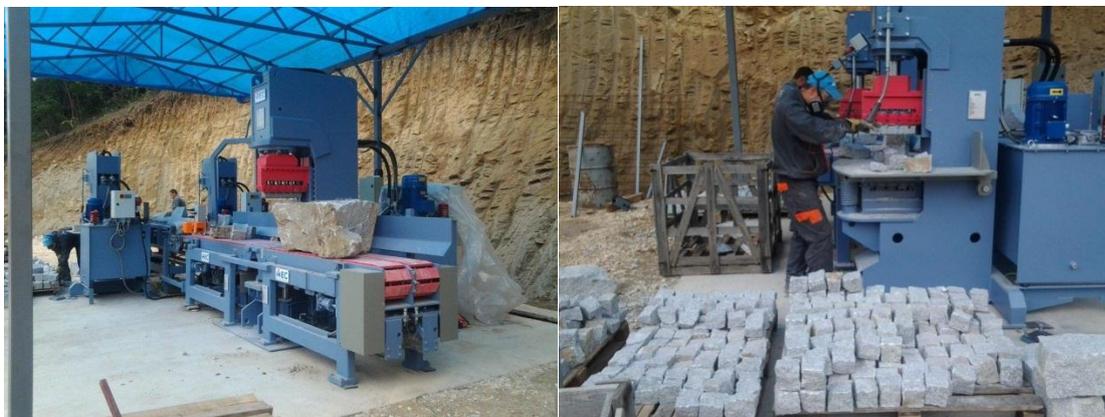
Figure 5-2 Rock cutting machine made by MEC factory

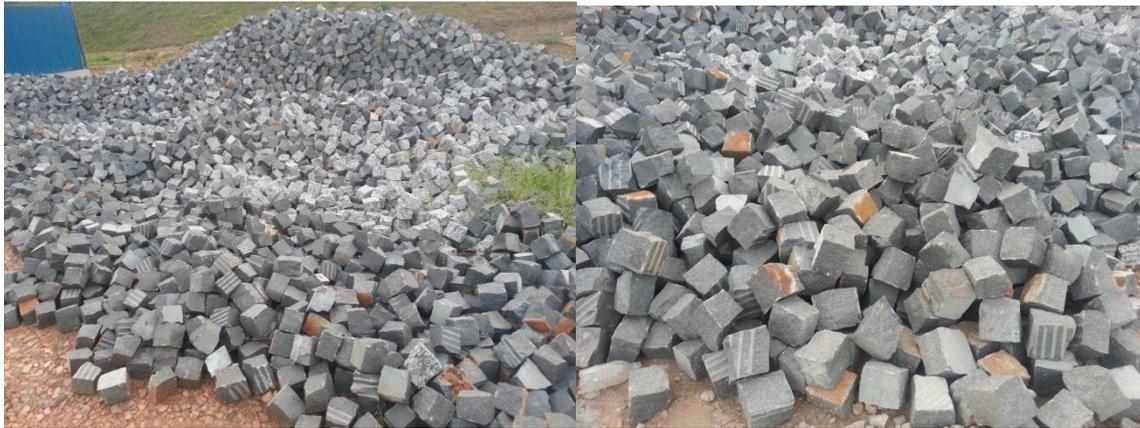
Figure 5-3: Locally produced mechanically cut stones by EAGI Nyagatare,

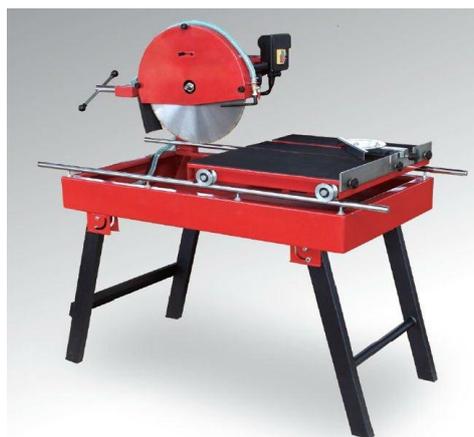
Figure 5-4: Small scale rock cutting machine

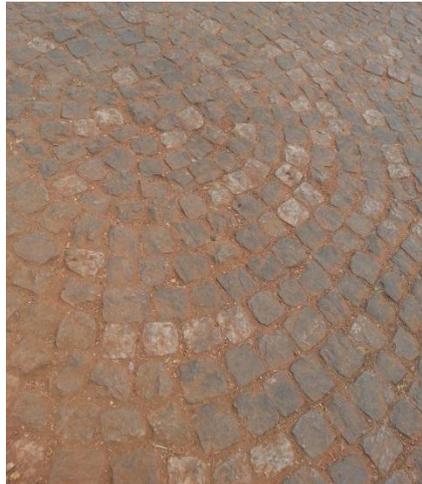
Figure 5-5 Recommended system of laying surfacing stone blocks

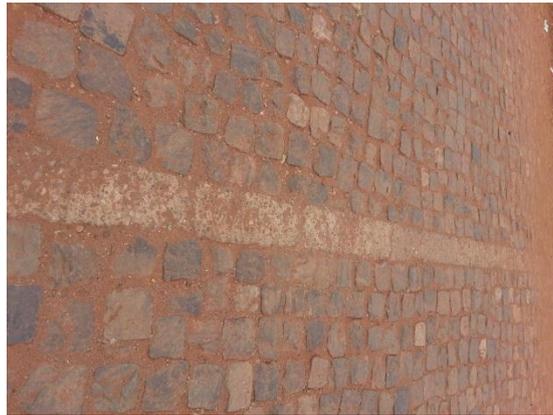
Figure 5-6: Strut block in concrete constructed at Gitega road, Kigali
