UNIVERSITY of
RWANDA

**TITLE: INVESTIGATION ON THE COMBINED EFFECT OF SEDIMENT EROSION
AND CAVITATION IN HYDRAULIC TURBINES
CASE STUDY OF GICIYE I AND GIHIRA HYDROPOWER PLANTS IN RWANDA**

A dissertation submitted in fulfillment of the requirements of the Degree of Masters of Science in Renewable Energy, African Center of Excellence in Energy for Sustainable Development(ACE-ESD), College of Science and Technology, University of Rwanda.

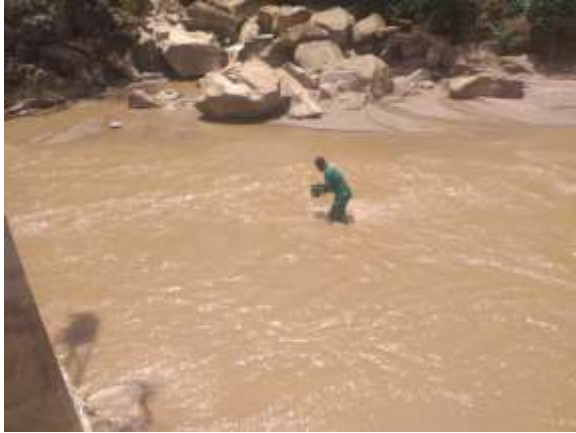
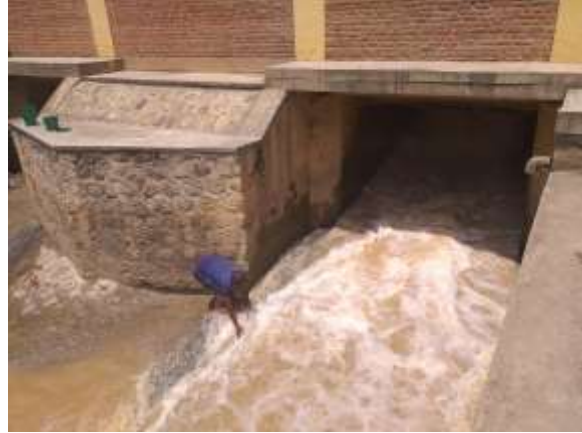
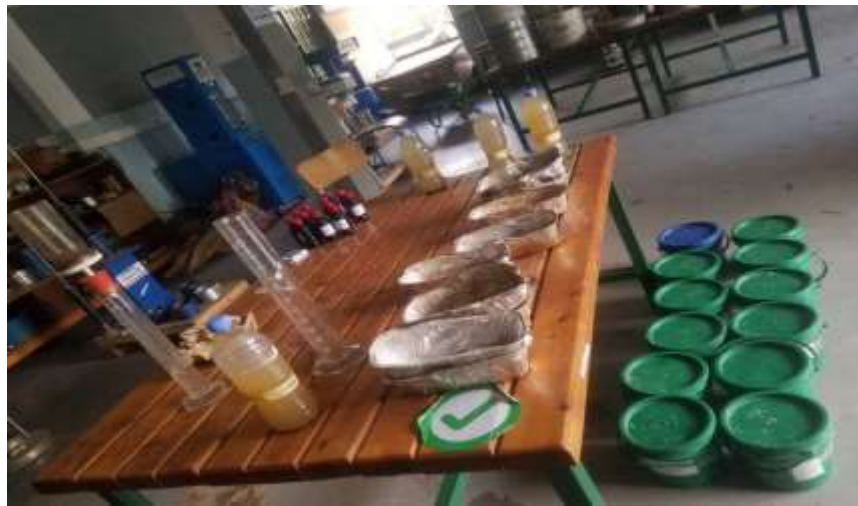
Picture 3.1 sampling

a) Sampling at the intake

b) Sampling at the tailrace

c) Samples taken

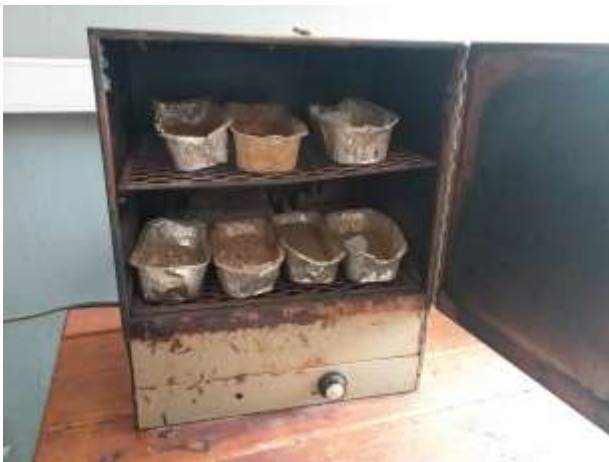
Picture 3.2 drying of samples in the oven

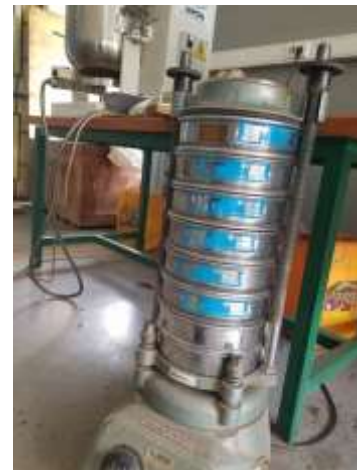
Picture 3.3 sieving test

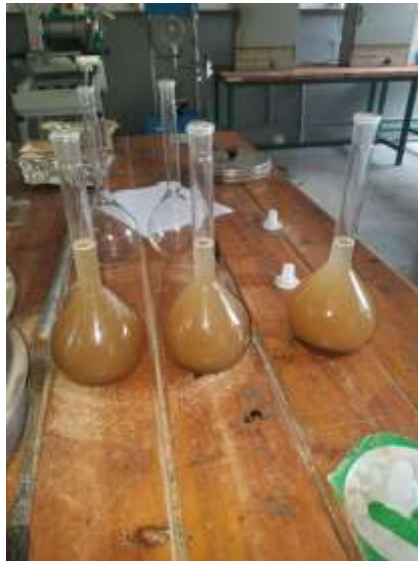
Picture 3.5 specific gravity test

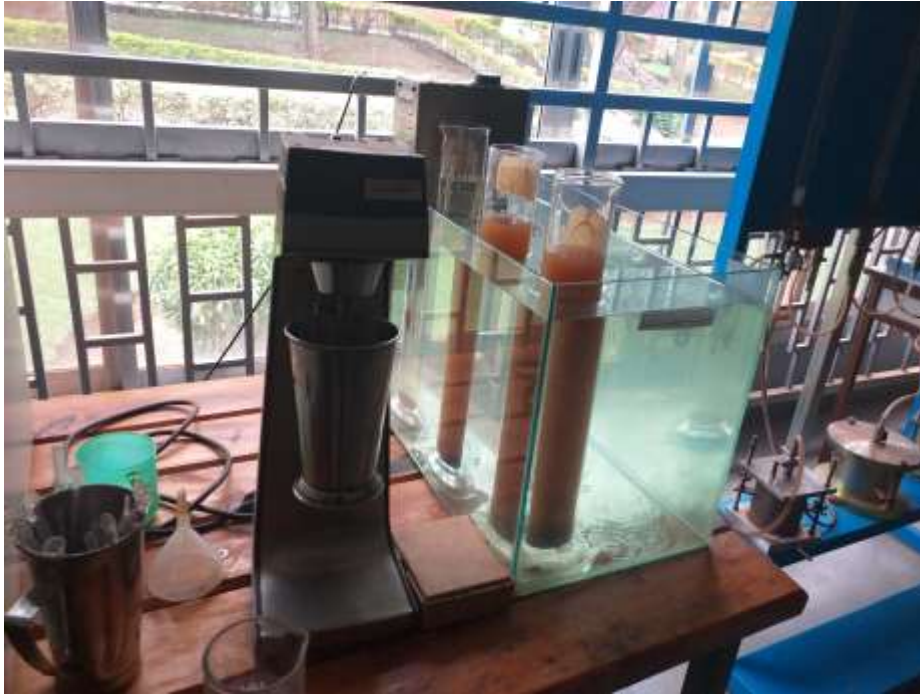
- A sensitive balance up to 0.01 g
- Stirring Apparatus
- Hydrometer
- Sedimentation cylinder
- Thermometer
- Sieves
- Water bath/Constant temperature room
- Beaker
- Timing device

Picture 3.6 hydrometer test

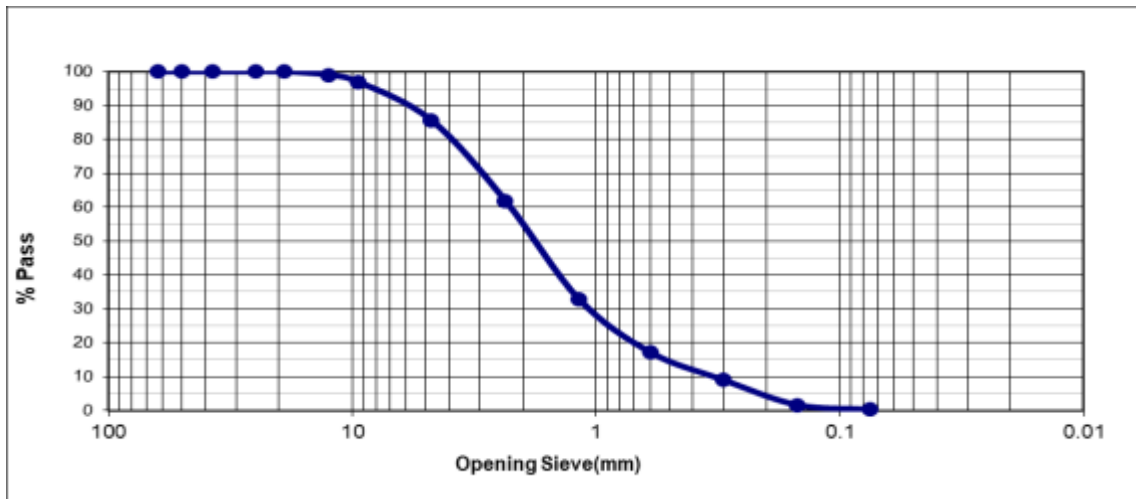
Figure 4. 2 Percentage pass vs sieve opening chart of Giciye intake middle point water

A total dry mass of 762.2g was taken at the middle point water of the intake of Giciye I hydropower plant was used as a sample to pass in the sieving test. The tests results showed that the sediment tested are composed by 15% of gravel, 85%.

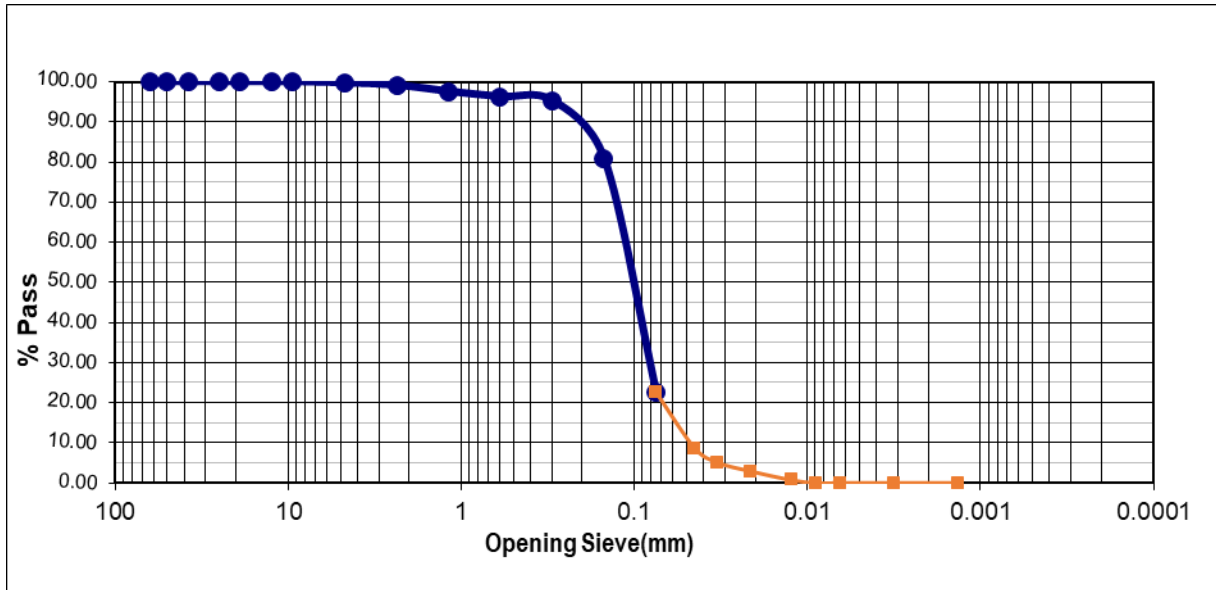
Figure 4.10 Percentage pass vs sieve opening chart of Sebeya tailrace top water

A total dry mass of 459.32g was taken at the top point water of the tailrace of Gihira hydropower plant was used as a sample to pass in the sieving test, for deep analysis the sediments of size below 0.075mm were taken for hydrometer test. The tests results showed that the sediment tested are composed by 77% sand and 22% of fine.

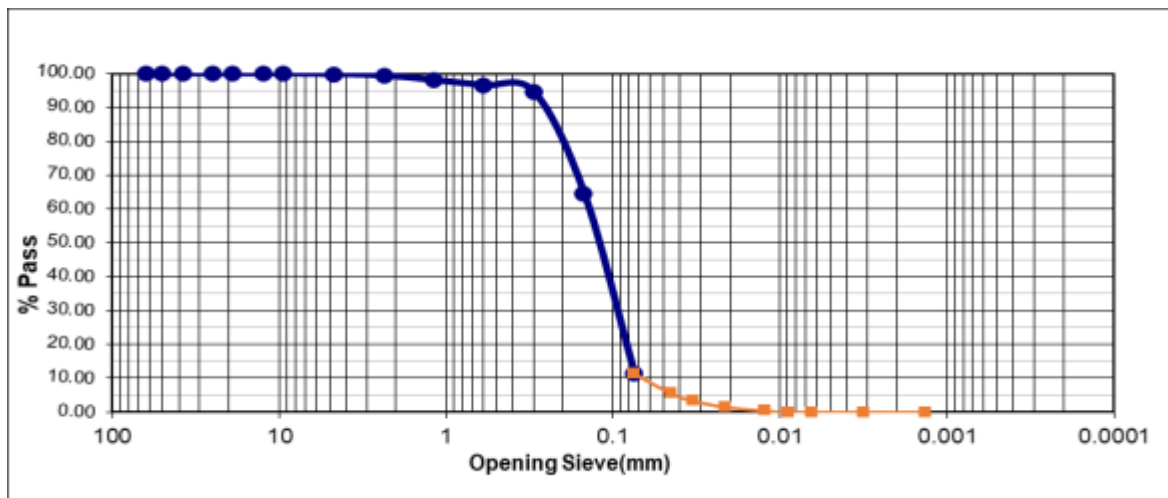
Figure 4. 11 Percentage pass vs sieve opening chart of Sebeya tailrace middle point water

A total dry mass of 605.11g was taken at the middle point water of the tailrace of Gihira hydropower plant was used as a sample to pass in the sieving test, for deep analysis the sediments of size below 0.075mm were taken for hydrometer test. The tests results showed that the sediment tested are composed by 88% sand and 11% of fine.

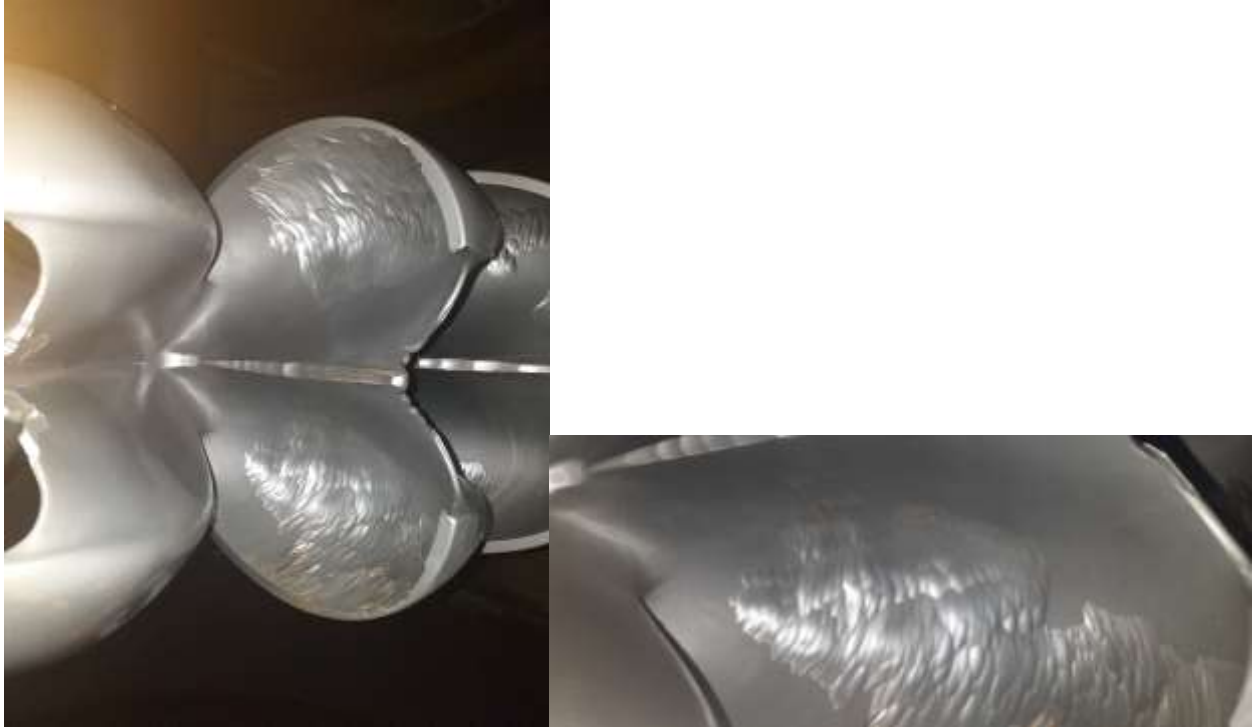
As said above the plant is in operation since June, 2014. However, the runner, nozzles, nozzle bars and other accessories were damaged and replaced by other with HVOF coating after one year and half of operation due to sediment erosion and cavitation.

The following photos are showing the combined effect of sediment erosion and cavitation to runner, and nozzles after 5 years of operation:

Picture 4.1 Combined effect of sediment erosion and cavitation to the runner blades

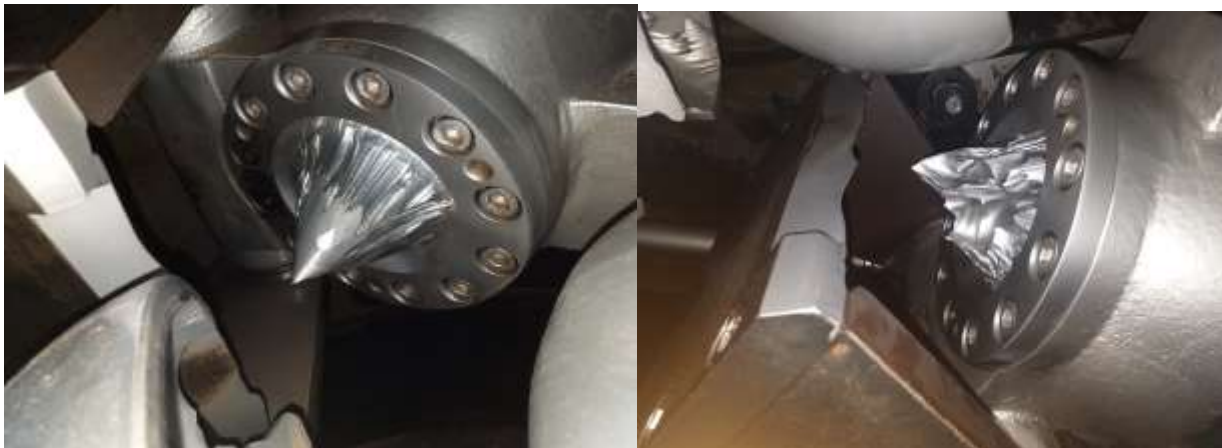
Picture 4.2 Combined effect of sediment erosion and cavitation to the turbine nozzles

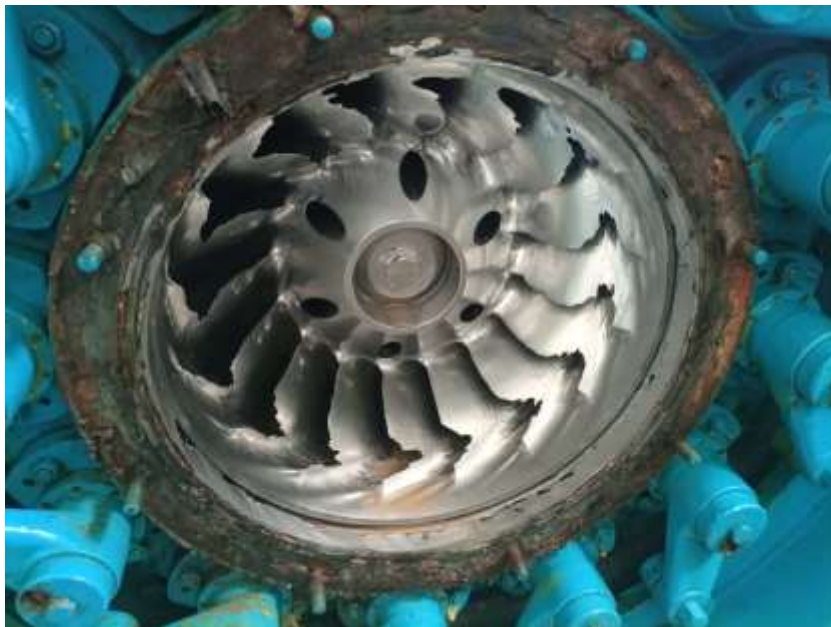
The following pictures are showing the combined effect of sediment erosion and cavitation of runner, wicket gates and sealing rings after 3 years and half of operation:

Picture 4.3 Combined effect of sediment erosion and cavitation to runner status

According to what have been seen during the turbine technical inspection and the information from the table 4.4, runner blades, wicket gates and sealing rings of Gihira I hydropower plant are facing a fine scaly erosion.

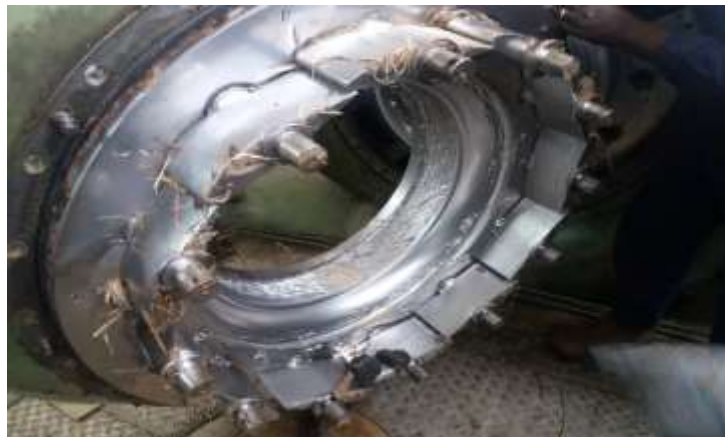
Picture 4.4 Combined effect of sediment erosion and cavitation to wicket gates

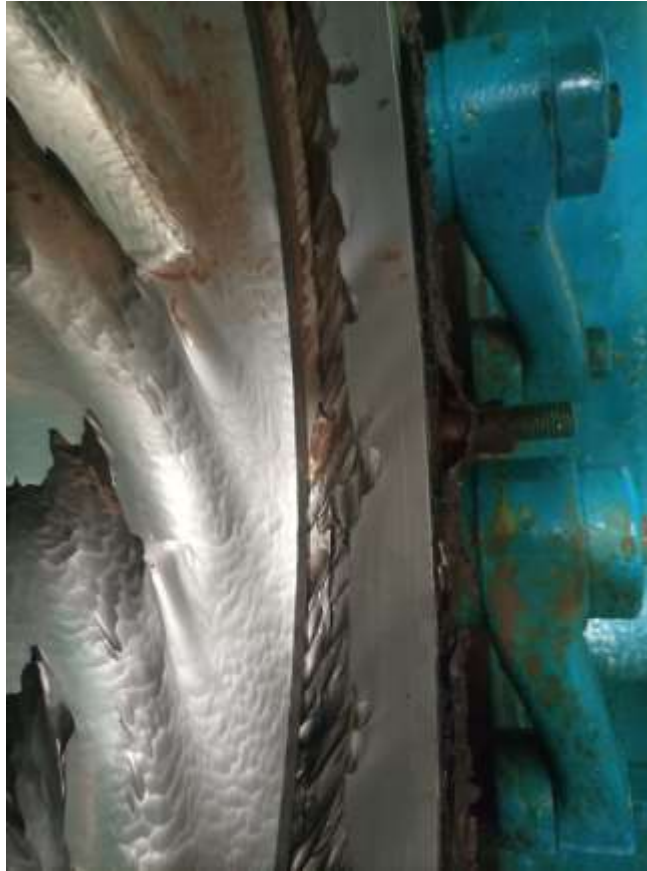
Picture 4.5 Combined effect of sand erosion and cavitation to sealing ring

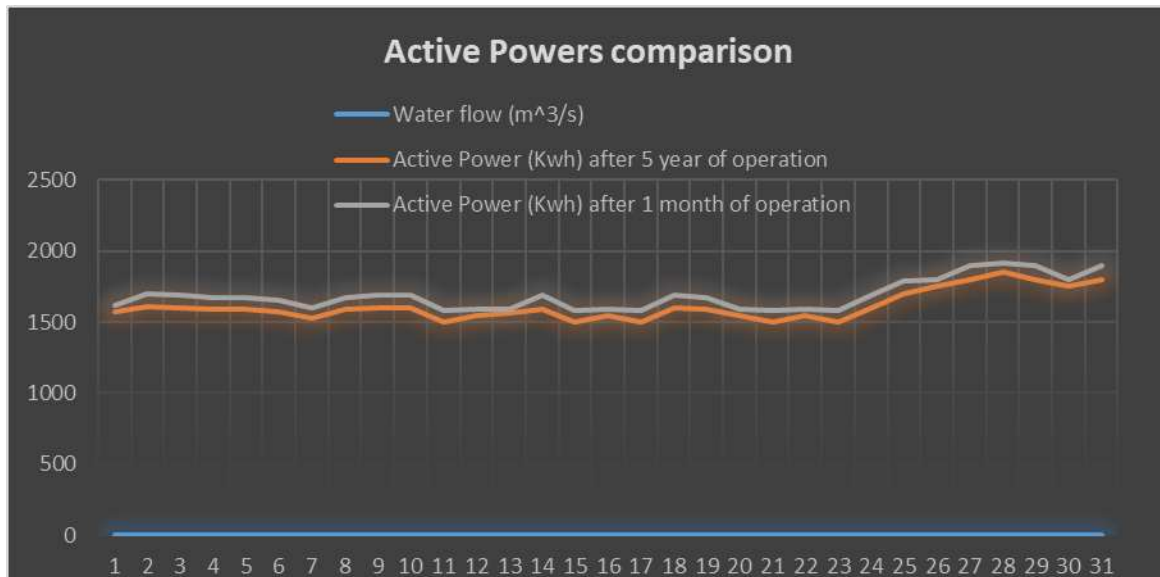
Figure 4. 13 Active powers production comparison

By comparing the active power production after one-month hydropower plant operation with the one after 5 year of operation, it is found that with the same water flow, the active power is decrease by 4.5% due to the combined sediment erosion and cavitation. This mean that the annual production energy is decreased by 4.5% which is a significant economic loss to the power plant owners.

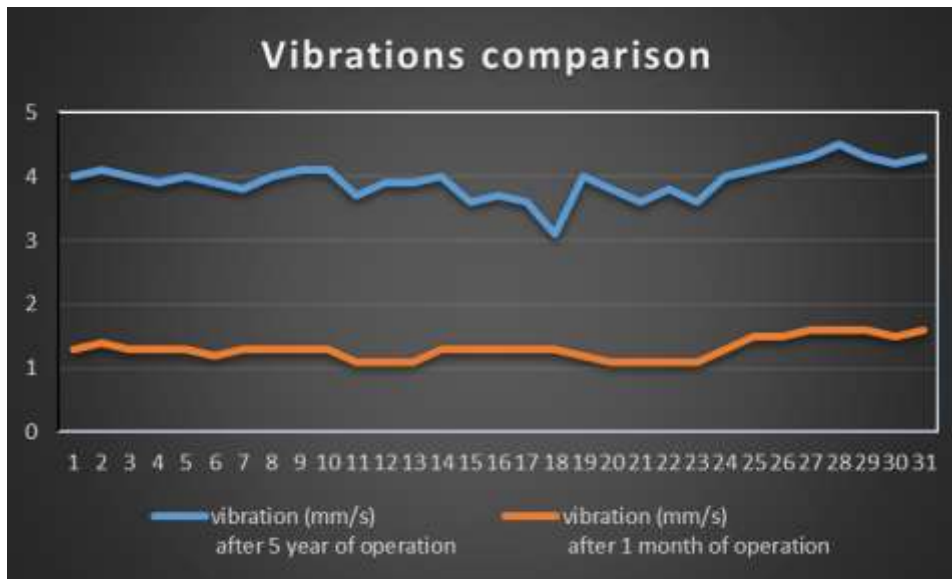
Figure 4. 14 Vibrations comparison

By comparing the vibration after one-month hydropower plant operation with the one after 5 year of operation, it is found that, the vibration is increased by 203%. There are many factors which should contribute to the increment of vibration such as damage of bearings, insufficient clearance between stationary and rotating parts but the major factor is extreme force fluctuations caused by cavitation and sediment erosion.

Vibrations contribute to the decrement of the life span of the turbine and its accessories without forgetting their contribution to the repetitive breakdowns of the turbines parts. You cannot avoid completely the vibration in hydraulic turbines but it should be minimized.

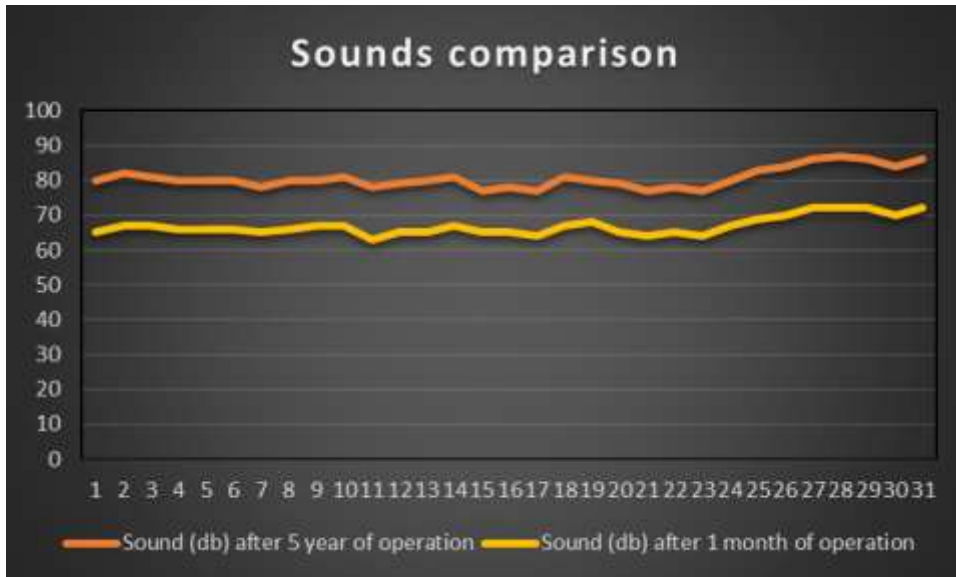
Figure 4. 15 comparison of sound

By comparing the sound after one-month hydropower plant operation with the one after 5 year of operation, it is found that, the sound/noises is increased by 20%.
