UNIVERSITY of
RWANDA

**AN ENGINEERING AND GIS-BASED EVALUATION OF THE FACTORS
CONTRIBUTING TO ROAD CRACKS AND BUILDING SETTLEMENTS: CASE STUDY
OF GATUNA ONE STOP BORDER POST**

**Thesis submitted to the University of Rwanda: College of Science and Technology in
partial fulfillment of the requirements for the award of the Degree of Master of Science in
Geo-Information Science for Environment and Sustainable Development.**

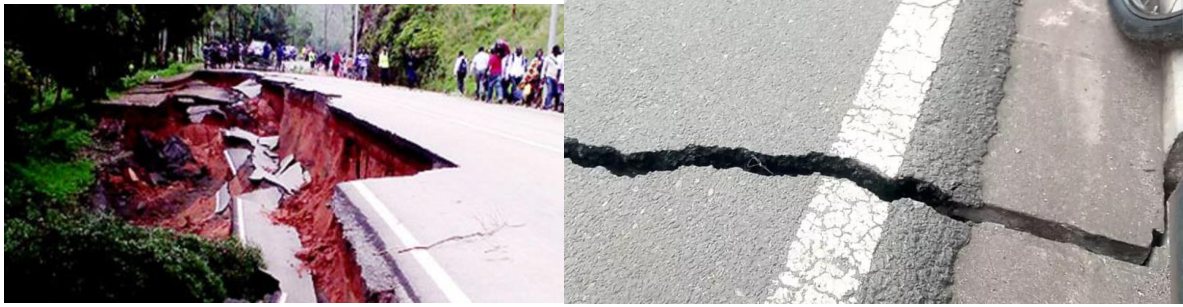
Figure 1: Deep crack caused by heavy rain in road of Kigali-Musanze, at Gakenke, Source: Newtimes, 2013), left and road crack in Rubavu, 2021(right, Newtimes, 2021).

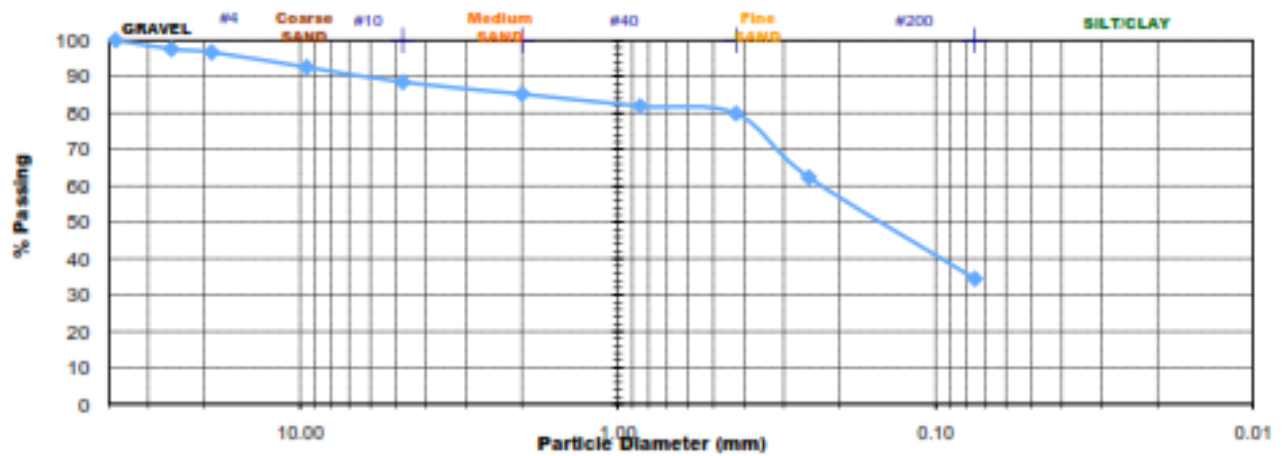
Grain Size Distribution Curve Results:

% Gravel: 11.5
 % Sand: 54.1
 % Fines: 34.4

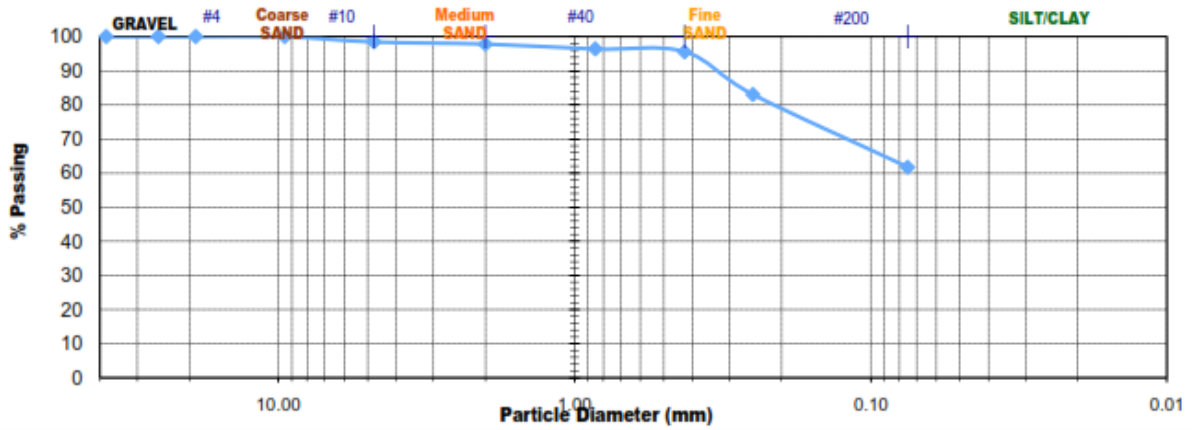
Grain Size Distribution Curve Results:

% Gravel: 1.6
 % Sand: 36.7
 % Fines: 61.7

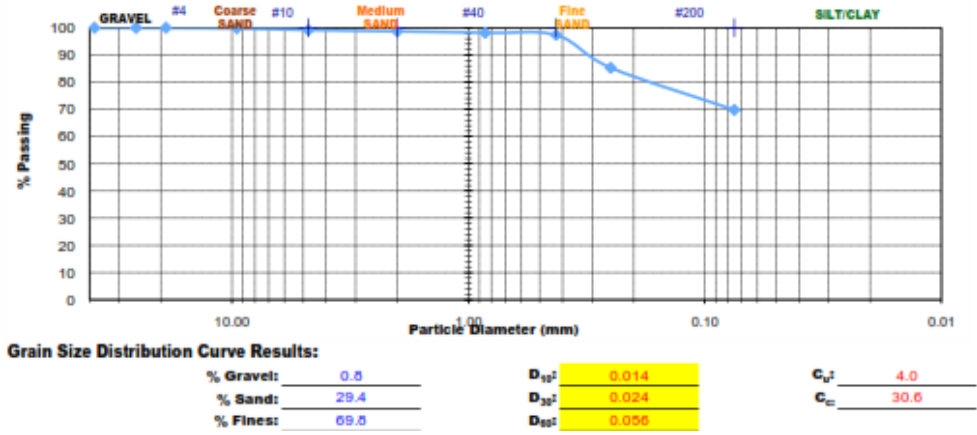
Figure 13: Results from the sieve analysis test for BH-03

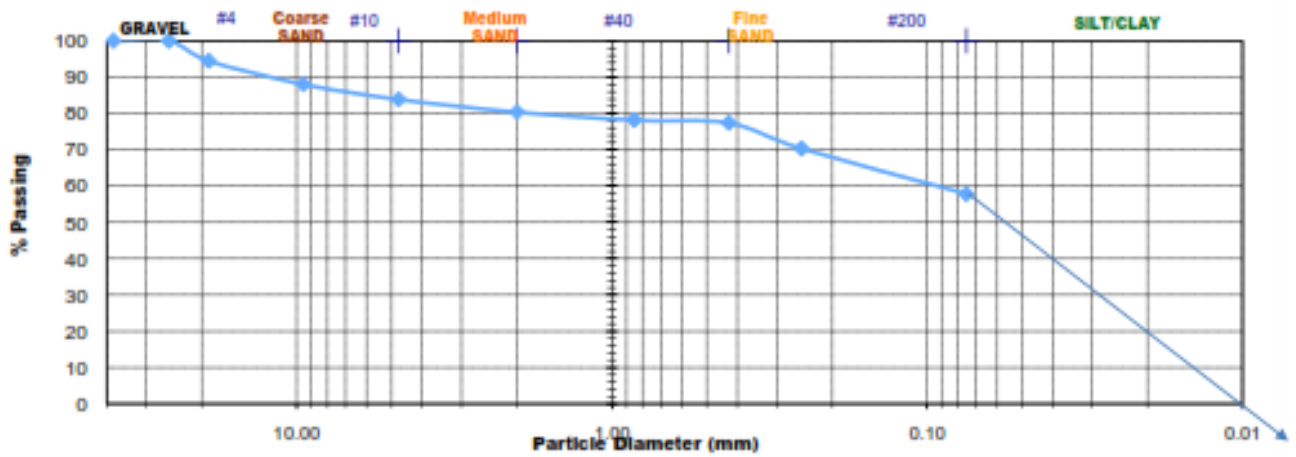
Grain Size Distribution Curve Results:

% Gravel: 16.1
 % Sand: 26.1
 % Fines: 57.8

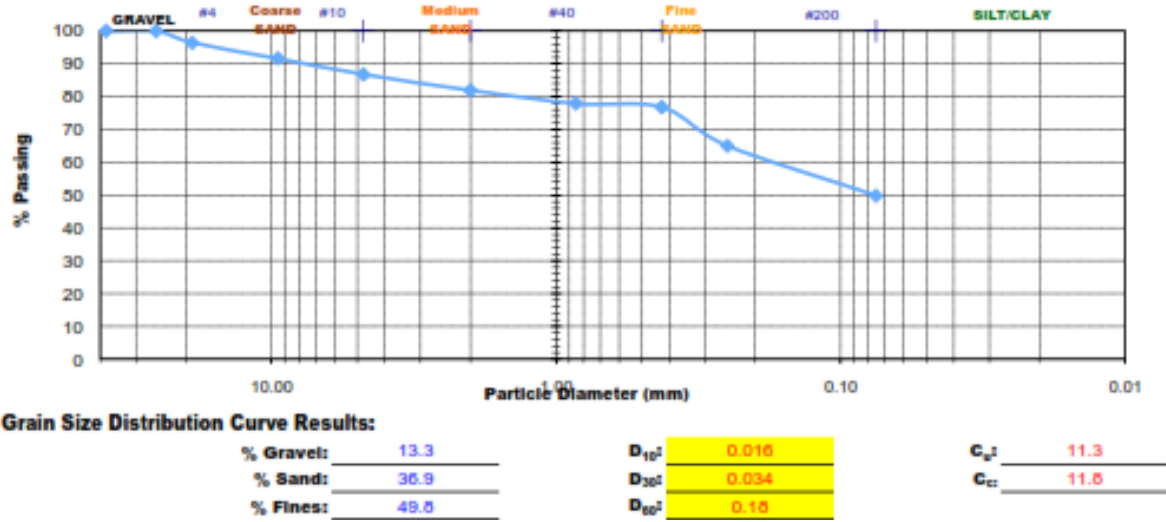
Figure 15: Results from the sieve analysis for BH-05

Therefore, considering the sieve analysis results from the geotechnical study done by RMTC Ltd, the formula of Slichter (1898) was used for determination of the hydraulic conductivity of different geologic layers.

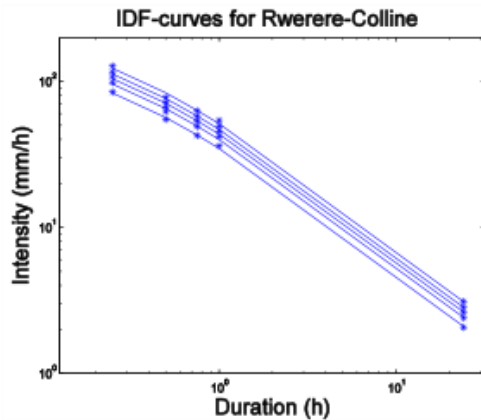
Figure 17: IDF Curves representation for RWERERE Station

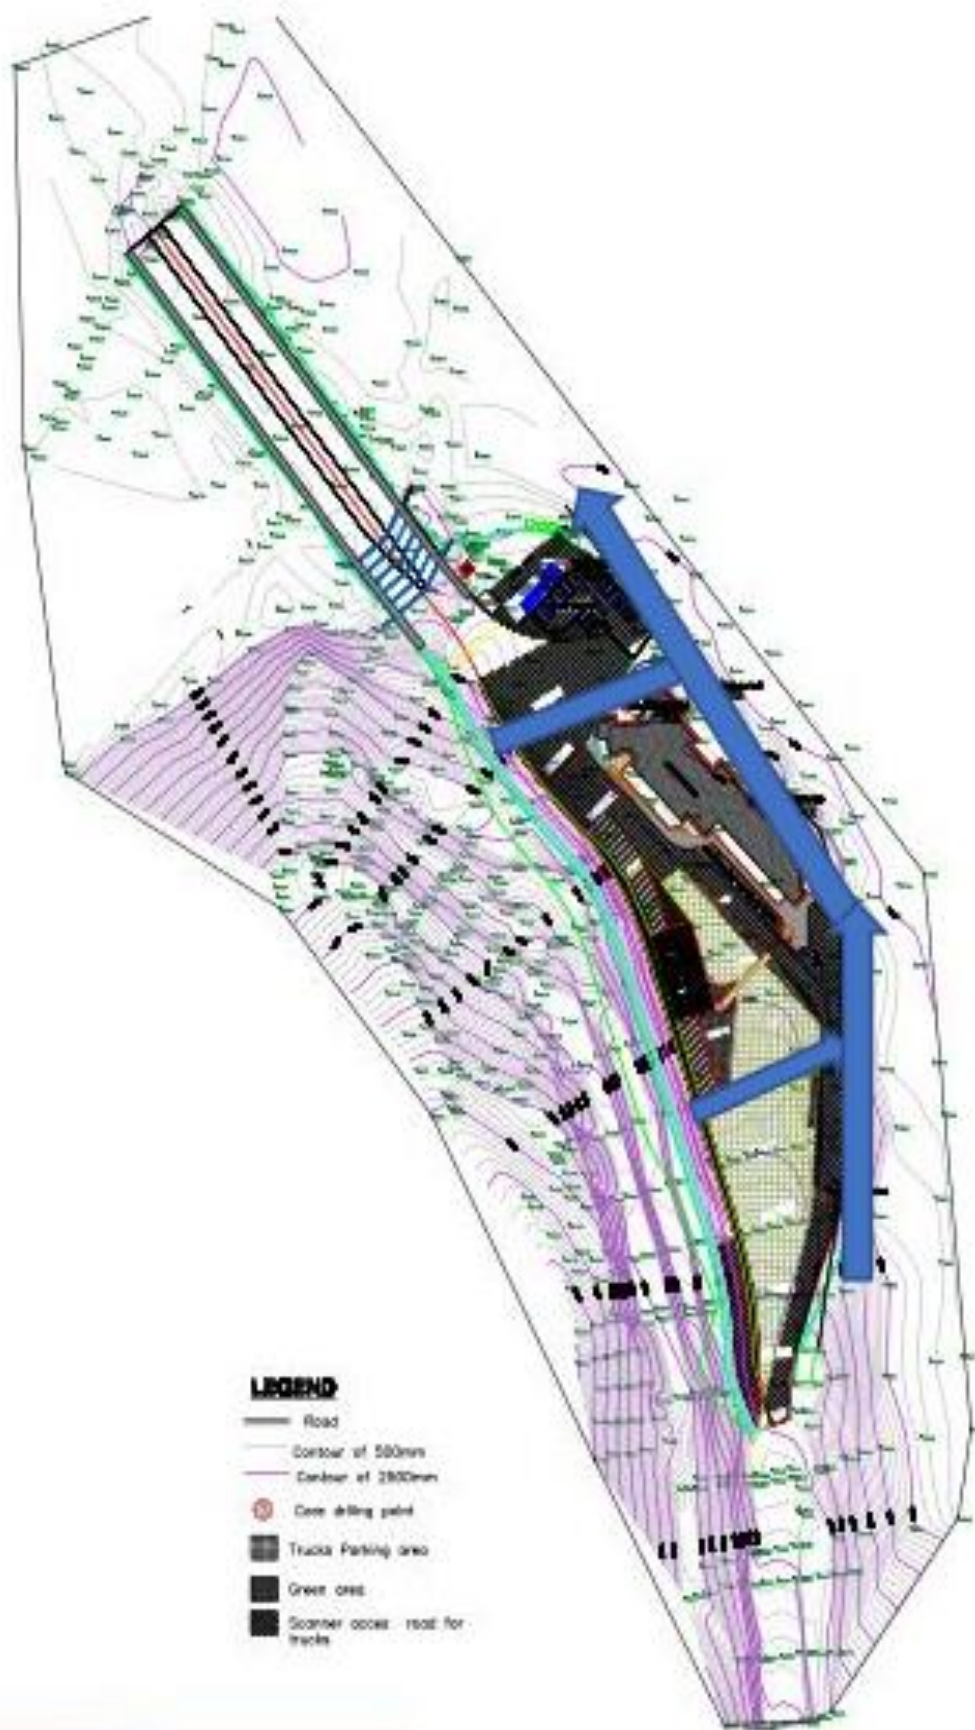
Figure 18: Layout of the proposed drainage system

The arrows in blue represent the proposed drainage system.

By considering the need of limiting the groundwater level under the foundation it is proposed to fill the trench with filter material (especially gravels) that will play also a role of supporting the uphill soil. Therefore, the channel will be of the following dimensions: height of 1.2 m and 1.2 m wide. To avoid the escape the fines a geotextile is required between soil and filter material.

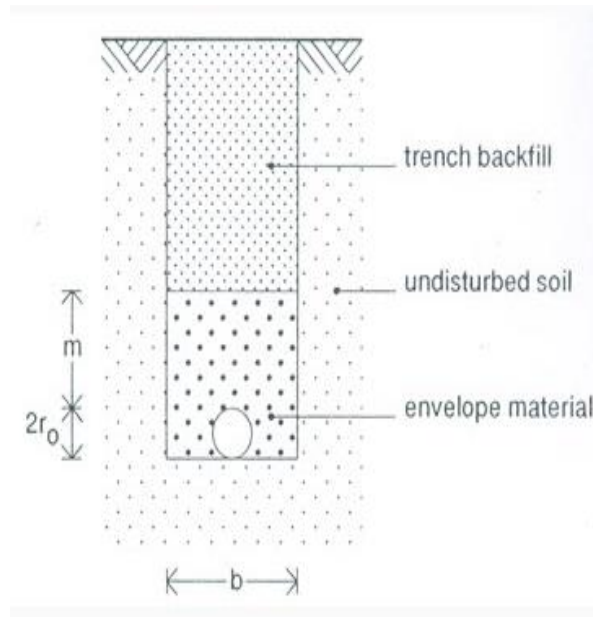
The proposed drain pipe is shown in figure 3, and it will be installed at 5.5 m for the lateral drains and at 1.2 m for the collector. The designed longitudinal slope is of 3%.

Figure 19: Sketch of the proposed pipe drain

Filters for drains are permeable materials placed around the drains for the purpose of preventing fine-grained materials in the surrounding soils from being carried into the drain by ground water. Envelopes for drains are permeable materials placed around the drains for the purposes of improving flow conditions in the area immediately surrounding the drain, and for improving bedding conditions.

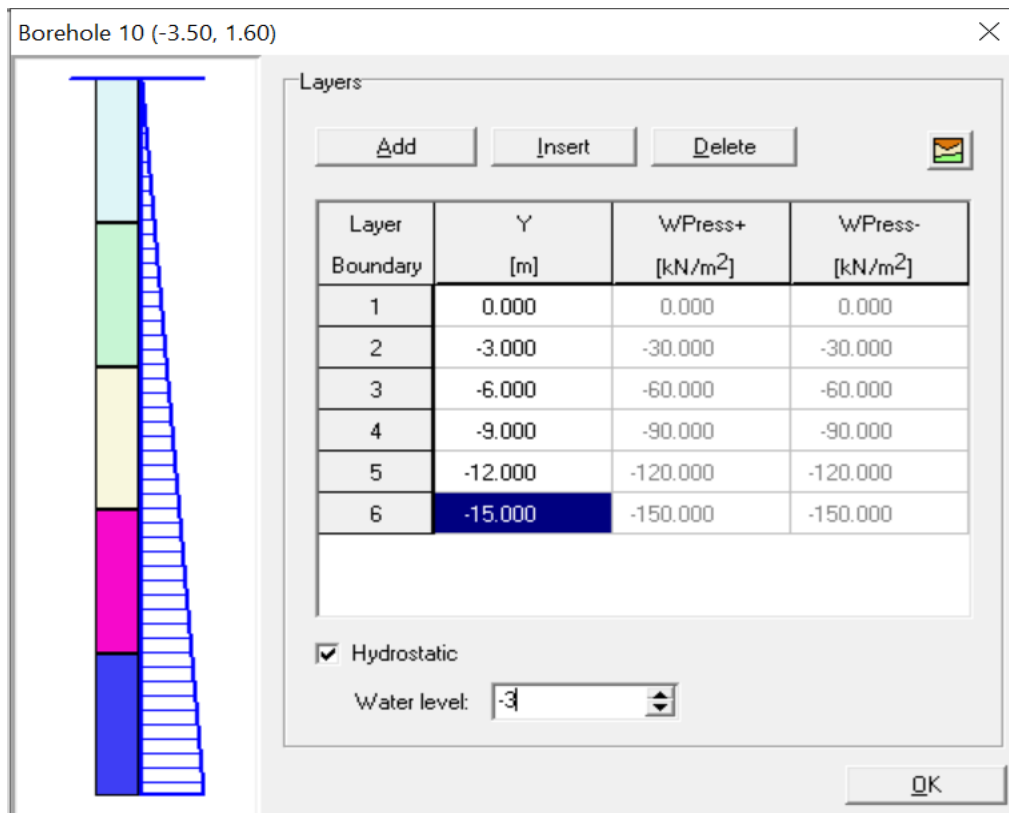
Figure 20: Settlement analysis

As per the figure above layers under foundation are considered for the model

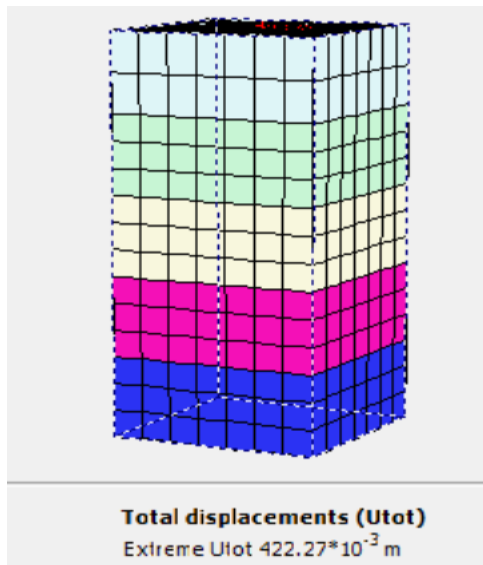
Figure 21: Total displacement

Typical higher values were obtained for some pad foundation under combination of static and dynamic loads.

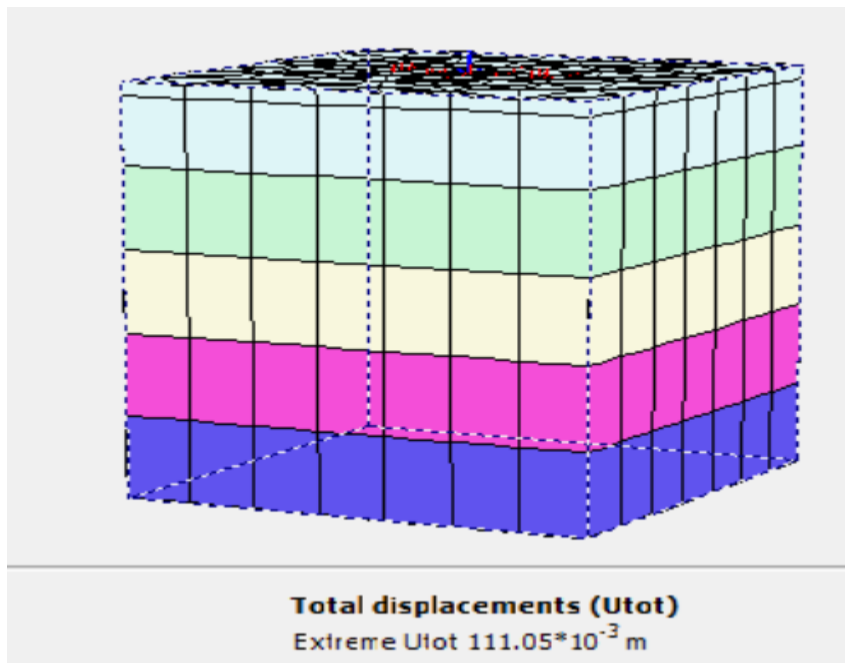
For the retaining wall the critical section of 4m high was analyzed and the total settlement calculated is 111mm, which is greater than 75mm but less than 135mm.

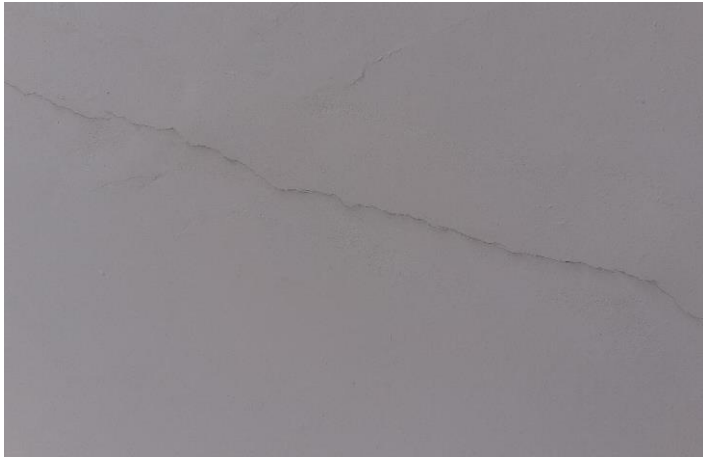
The presence of cracks solely in the exterior masonry walls of the Gatuna Building raises concerns. Brick masonry cracking often stems from various ground movements like clay shrinkage, vibration, settlement, and others. It's probable that the cracking in the Gatuna walls results from a blend of ground movement and foundation settlement. Addressing these issues promptly is crucial to ensure the structural integrity and safety of the building.

Figure 22: Cracking in the Gatuna walls

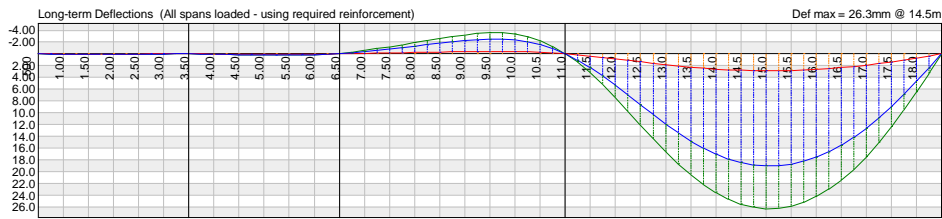
Beam deflection

Maximum long-term deflection: 2.63cm. Admissible deflection: $L/250 = 750/250 = 3\text{cm}$ OK.

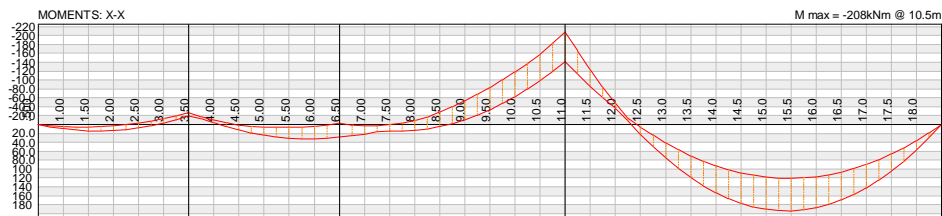
Bending moments

$M_{\text{max}}^- = 208\text{KNm}$

$M_{\text{max}}^+ = 194\text{KNm}$

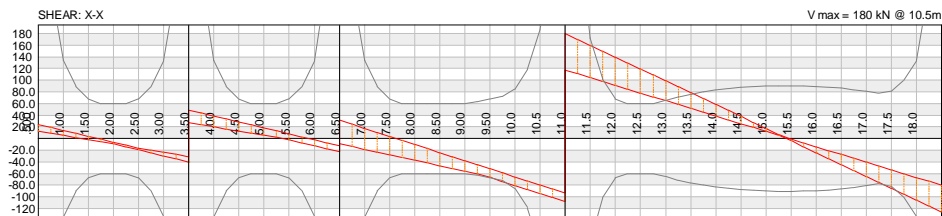
Shear forces

$V_{\text{max}} = 180\text{KN}$

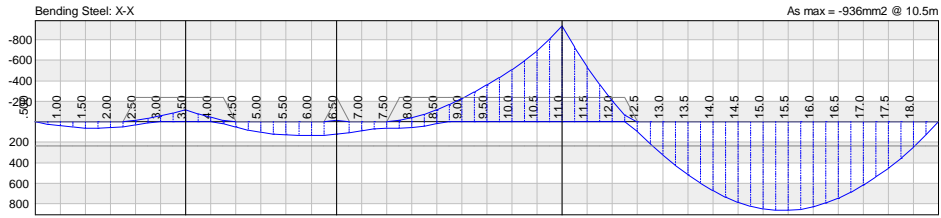
Required main steel reinforcement

As top: 936mm².

As bottom: 865 mm².

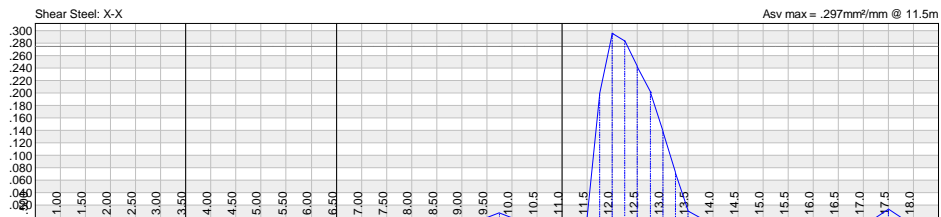
Required stirrups

Required: 0.297mm²/mm.

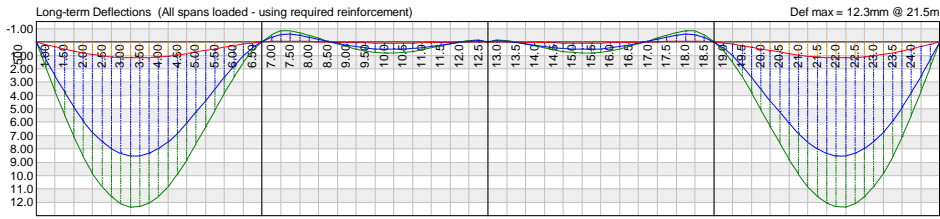
Beam deflection

Maximum long-term deflection: 1.23cm. Admissible deflection: $L/250 = 600/250 = 2.4\text{cm}$ OK.

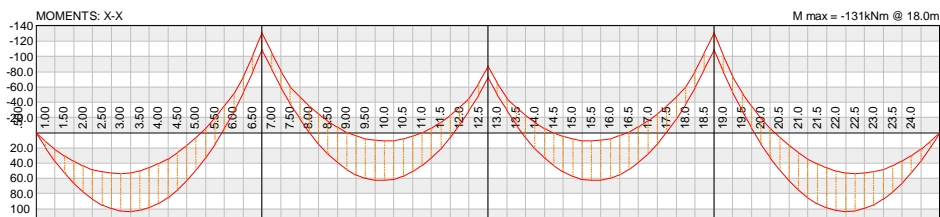
Bending moments

$M_{\text{max}}^- = 131\text{KNm}$

$M_{\text{max}}^+ = 104\text{KNm}$

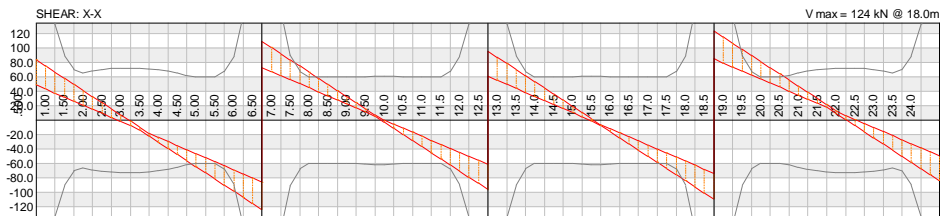
Shear forces

$V_{\text{max}} = 124\text{KN}$

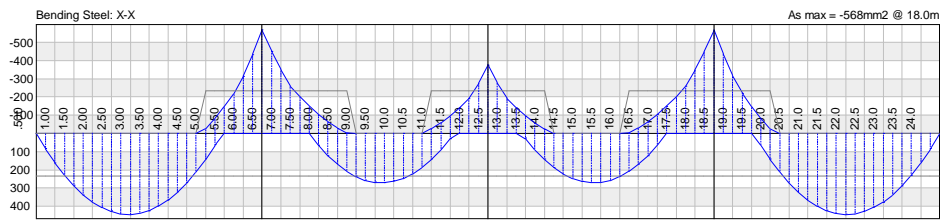
Required main steel reinforcement

As top: 568mm². < 3Φ20 = 942mm² = Existing steel

As bottom: 445mm² < 4Φ16 = 804mm² = Existing steel

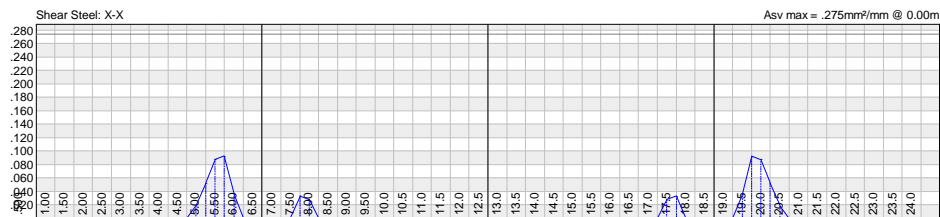
Required stirrups

Required: 0.275mm²/mm < existing 2Φ8@150mm = 0.673mm²/mm

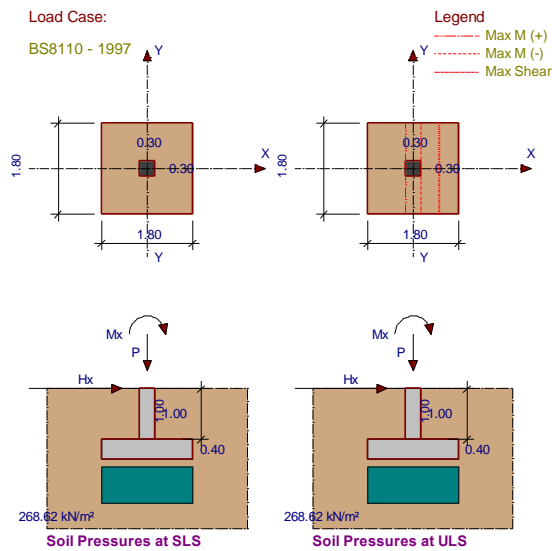
D. DESIGN OF FOUNDATIONS USING DESIGN LOADS

Required steel reinforcement

Output for Load Case	
Soil pressure (ULS)(kN/m ²)	268.62
Soil pressure (SLS)(kN/m ²)	268.62
SF overturning (SLS)	>100
SF overturning (ULS)	>100
Safety Factor slip (ULS)	>100
Safety Factor uplift (ULS)	>100
Bottom	
Design moment X (kNm/m)	67.78
Reinforcement X (mm ² /m)	466
Design moment Y (kNm/m)	67.78
Reinforcement Y (mm ² /m)	466
Top	
Design moment X (kNm/m)	0.00
Reinforcement X (mm ² /m)	0
Design moment Y (kNm/m)	0.00
Reinforcement Y (mm ² /m)	0
Linear Shear X (MPa)	0.273
vc (MPa)	0.347
Linear Shear Y (MPa)	0.273
vc (MPa)	0.347
Linear Shear Other (MPa)	0.000
Punching Shear (MPa)	0.162
vc (MPa)	0.347
Cost	613.47
